# Geomorphological Assessment and Stabilization Recommendations

## Watercourse 9 – Craigeith Proposed Residential Development

Report Title: Fluvial Geomorphology Assessment and Stabilization  
Recommendations  
Watercourse 9 - Craigleith Proposed Residential  
Development

Project Number: PN20058  
Status: Final  
Version: 2.0  
First Submission Date: September 11, 2020

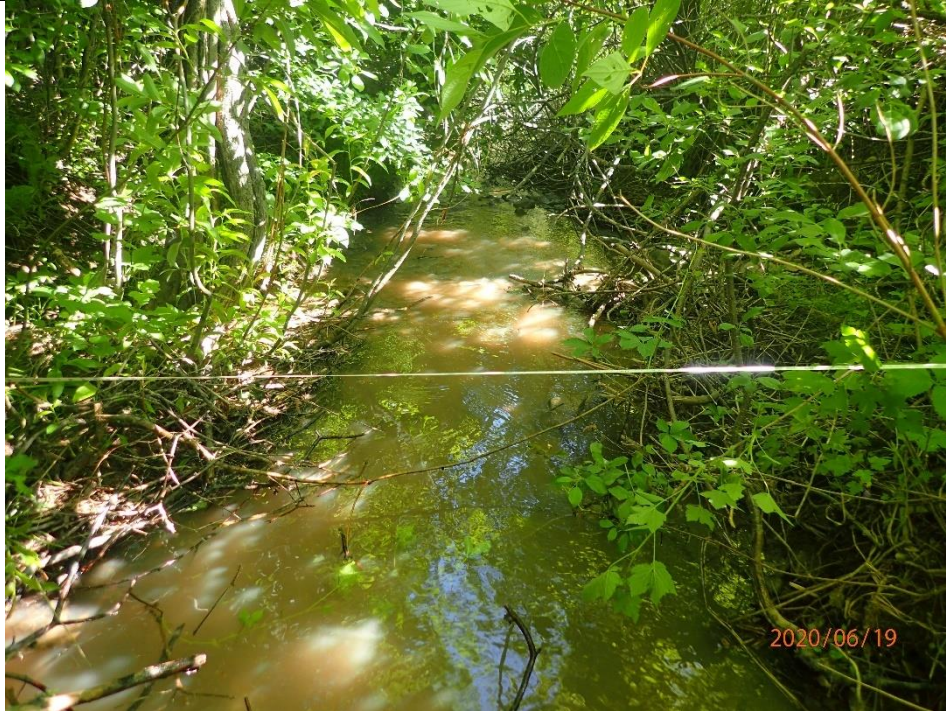
**Photo 1**  
Reach WC9 DS – Town of the Blue Mountains, Ontario

Looking downstream at the furthest downstream extent of the reach and proposed outfall location. Watercourse 9 flows through a mix of forested and pasture lands, with mature tree species continuously occupying the riparian zone.

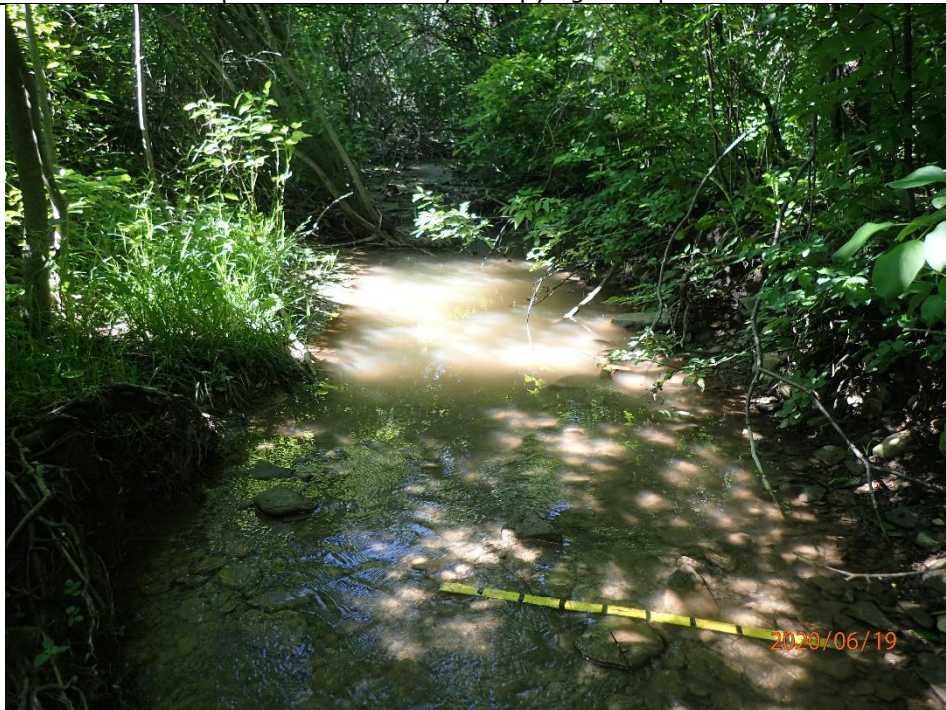
**Photo 2**  
Reach WC9 DS – Town of the Blue Mountains, Ontario

Riffle substrate ranged from gravel to cobble, with low embeddedness of coarse materials. Basal scour was present on both sides of the channel through riffles and is evident of channel of widening.

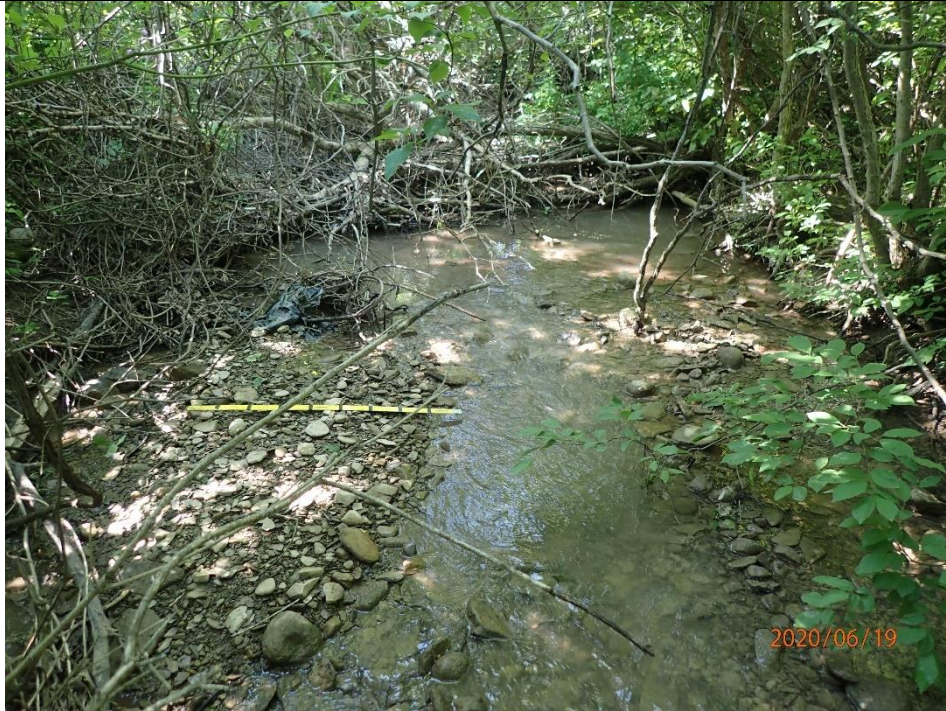
**Photo 3**  
Reach WC9 DS – Town of the Blue Mountains, Ontario

Bars were poorly formed and reworked throughout the reach. Poor longitudinal sorting of bed materials was observed.

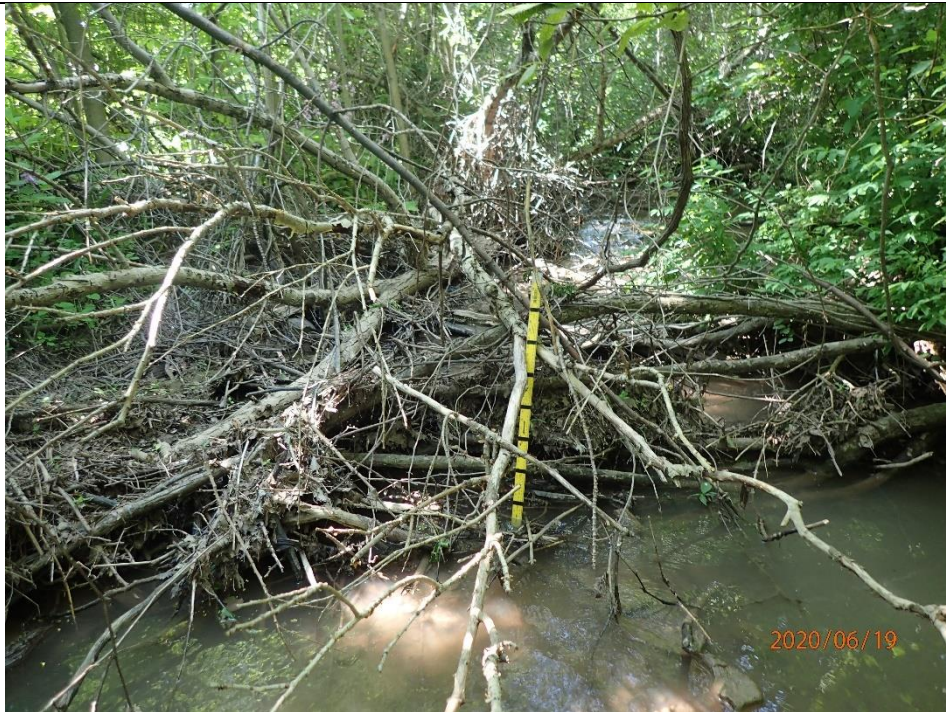
**Photo 4**  
Reach WC9 DS – Town of the Blue Mountains, Ontario

There was a high density of woody debris present in the channel and cut bank. There were approximately 5 woody debris jams per 50 m of the reach.

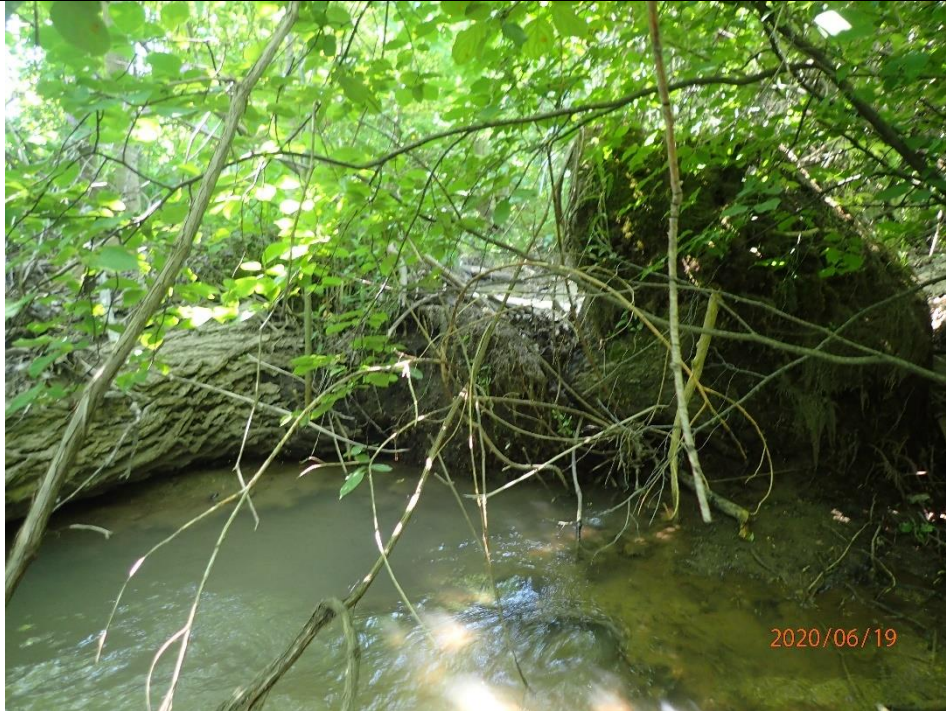
**Photo 5**  
Reach WC9 DS – Town of the Blue Mountains, Ontario

Leaning and fallen trees were frequently noted through the extent of the reach. Leaning and fallen trees, as well as undercutting, provided evidence of channel widening.

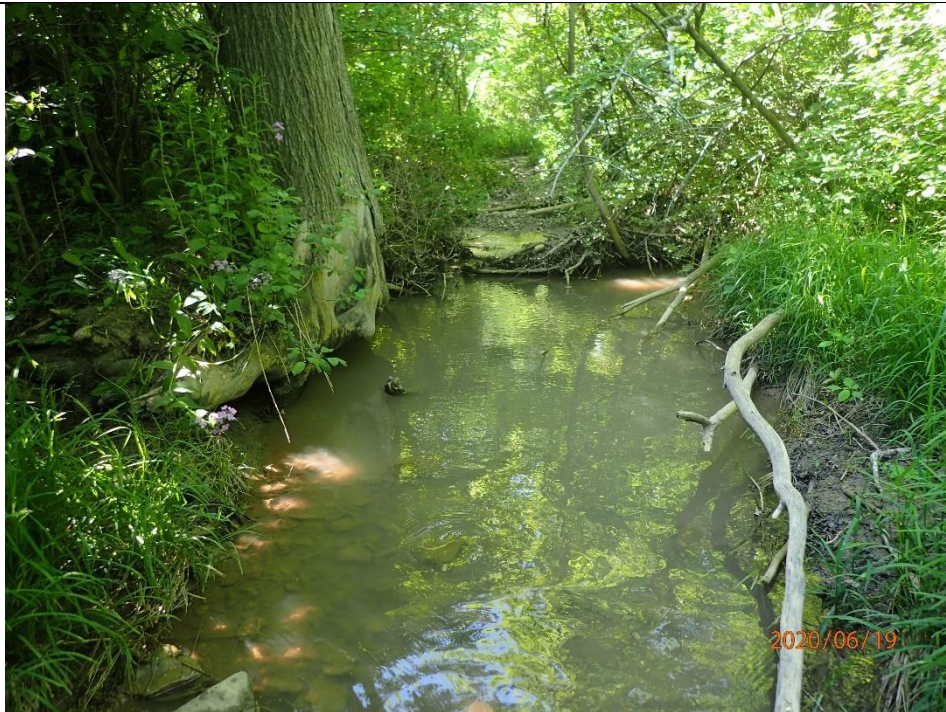
**Photo 6**  
Reach WC9 DS – Town of the Blue Mountains, Ontario

Bank erosion was present through 30 to 60% of the reach and was observed through scouring of the channel banks. Basal scour was observed along more than 50% of total length.

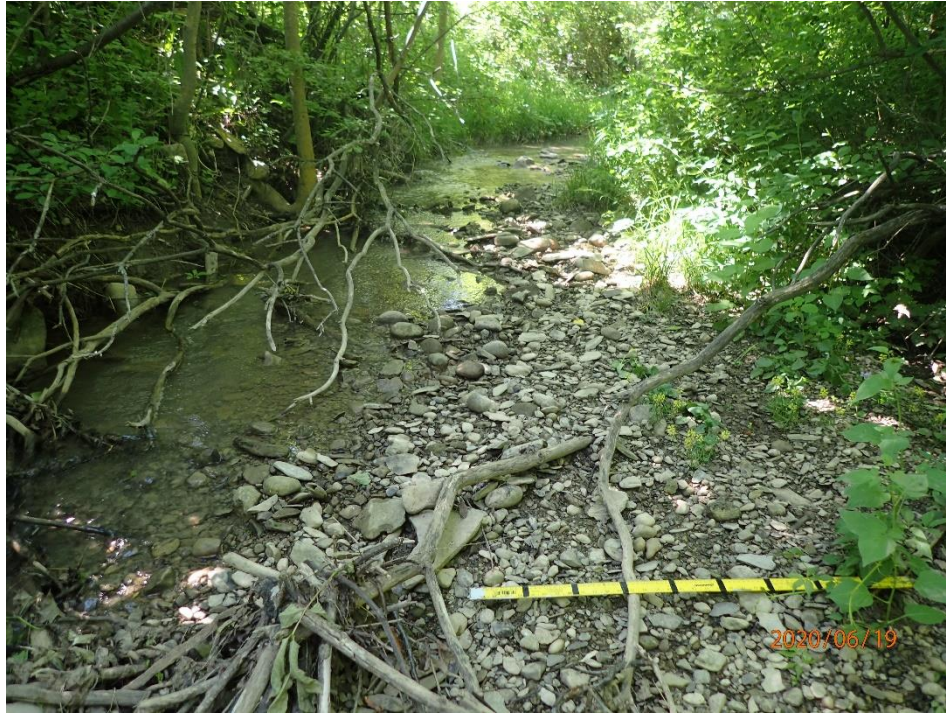
**Photo 7**  
Reach WC9 DS – Town of the Blue Mountains, Ontario

Thalweg alignment was out of phase with meander form and was observed in conjunction with poorly formed/reworked/removed bar forms.

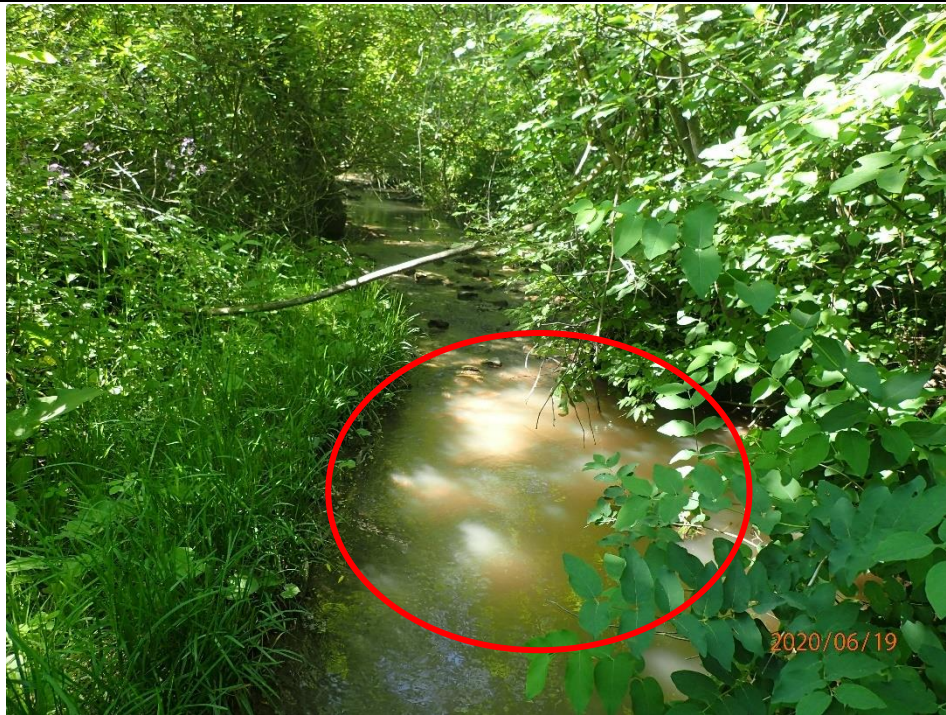
**Photo 8**  
Reach WC9 DS – Town of the Blue Mountains, Ontario

There was a good mix between riffles, runs and pools through the subject reach providing good physical instream habitat. Siltation in pools (circled) was indicative of aggradation.

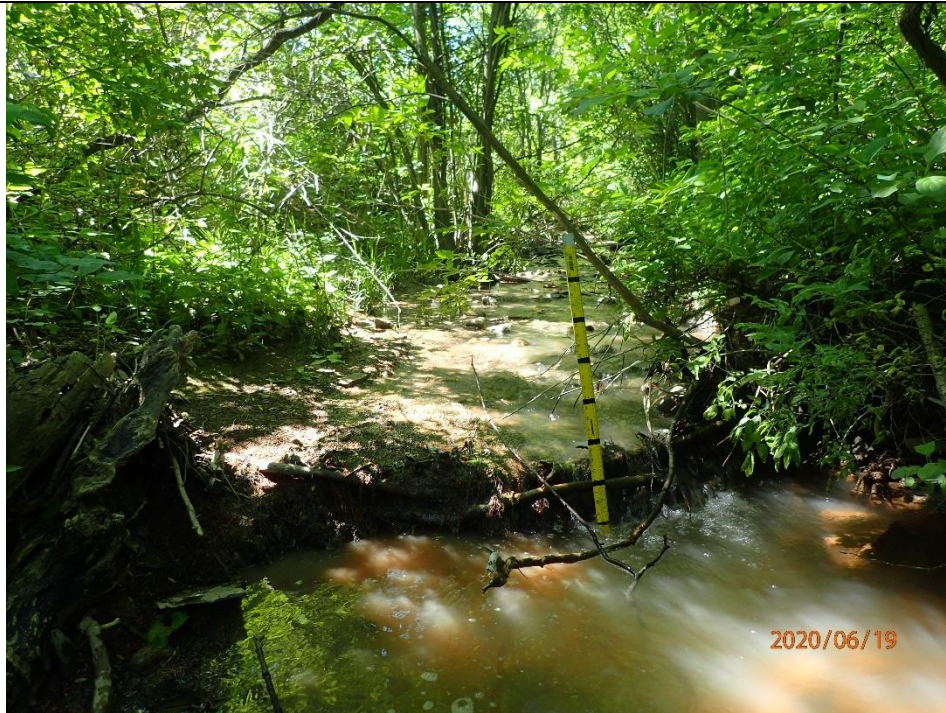
**Photo 9**  
Reach WC9 DS – Town of the Blue Mountains, Ontario

A rooted knickpoint was observed with apparent head-cutting due to knickpoint migration upstream.

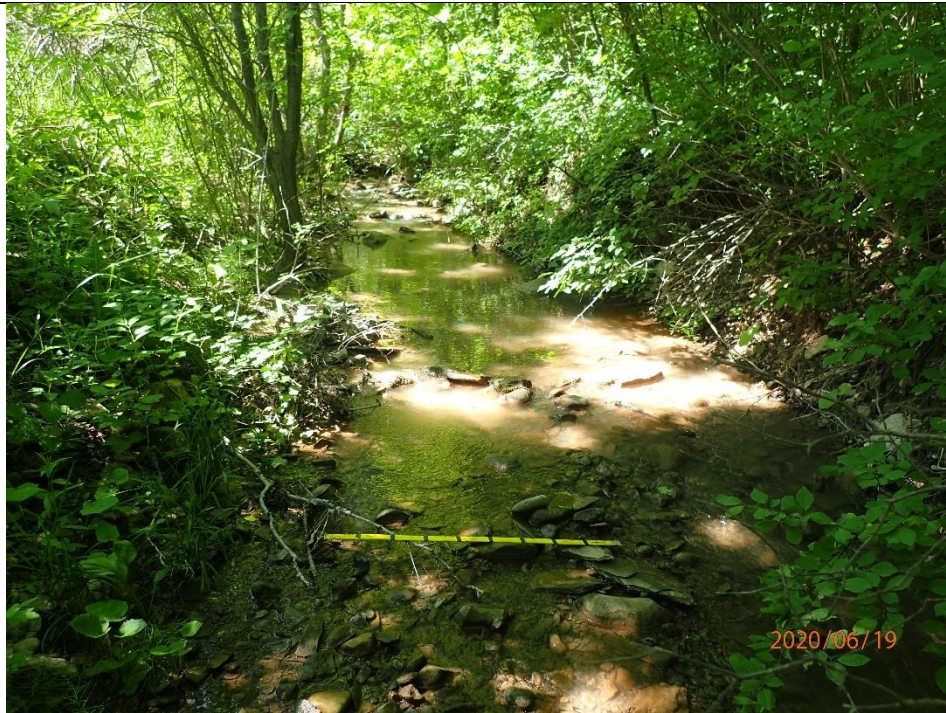
**Photo 10**  
Reach WC9 DS – Town of the Blue Mountains, Ontario

The wetted perimeter of the channel occupied > 85% of the bottom channel width. This improved physical instream habitat conditions.

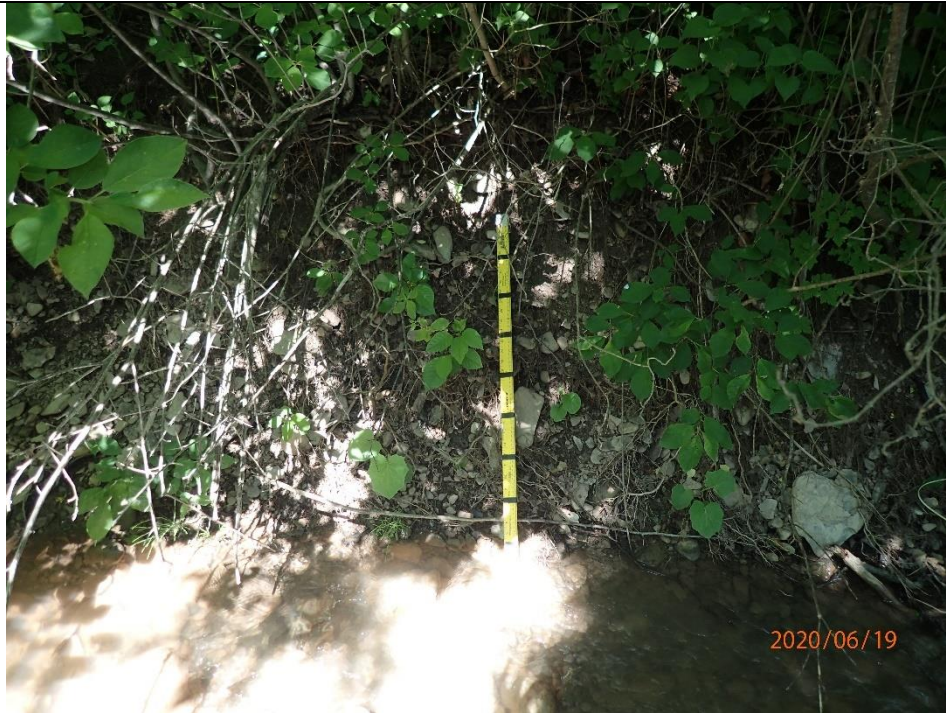
**Photo 11**  
Reach WC9 DS – Town of the Blue Mountains, Ontario

Young exposed tree roots were common throughout the reach. Moving upstream, the outer bank height increased to greater than 1 – 2 m above the stream bank, contributing to instability.

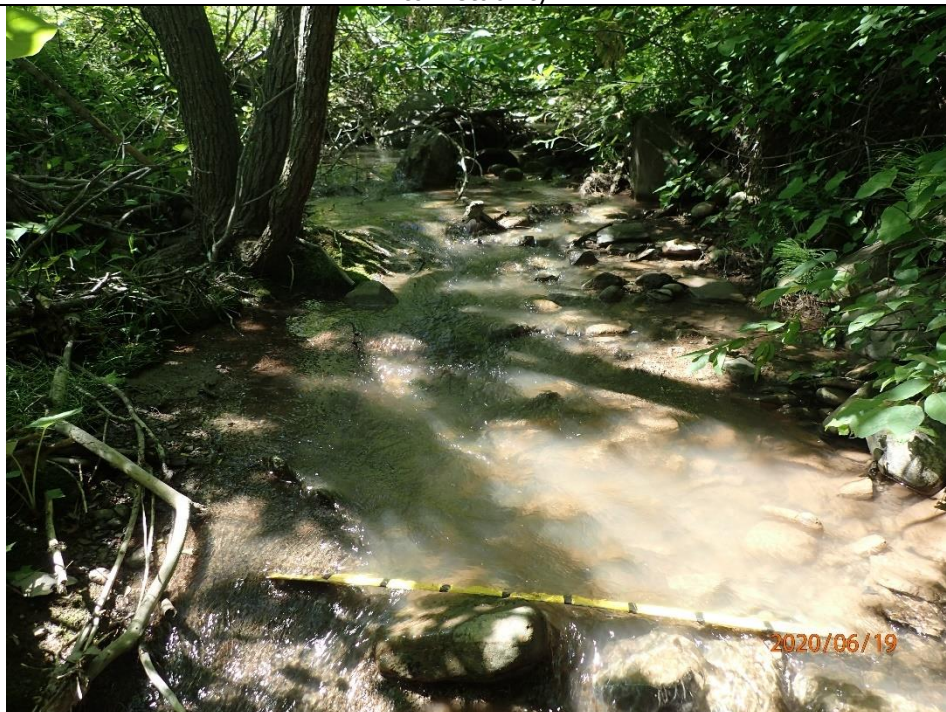
**Photo 12**  
Reach WC9 DS – Town of the Blue Mountains, Ontario

The reach was a defined, single thread channel with low sinuosity and a moderate gradient. Substrate size and bed load increased moving upstream, as observed by small to large boulders.

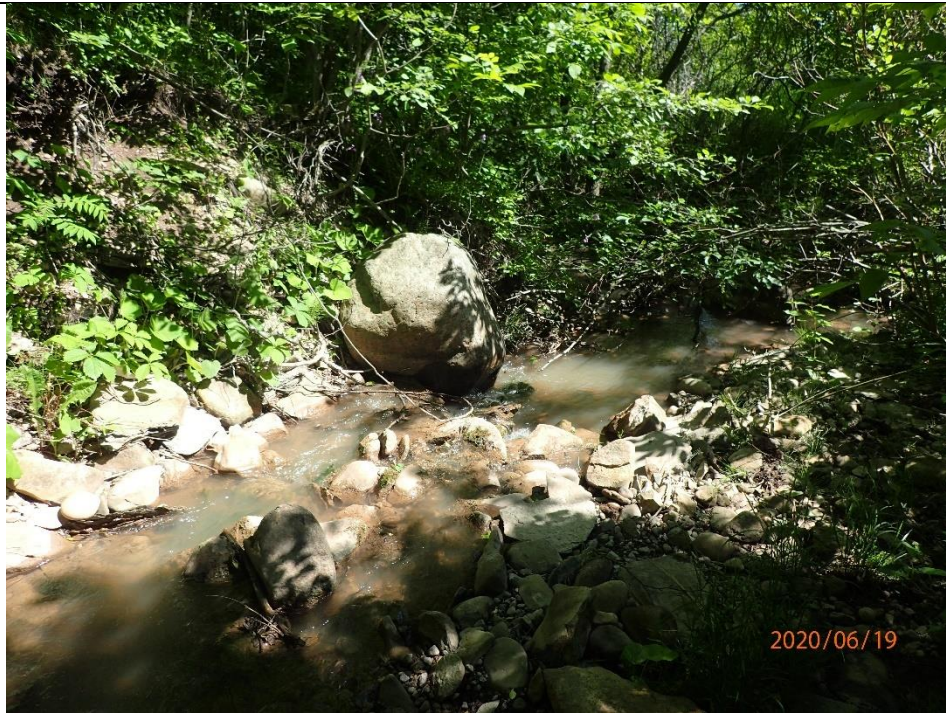
**Photo 13**  
Reach WC9 DS – Town of the Blue Mountains, Ontario

Looking downstream at the approximate location of a proposed watercourse crossing.

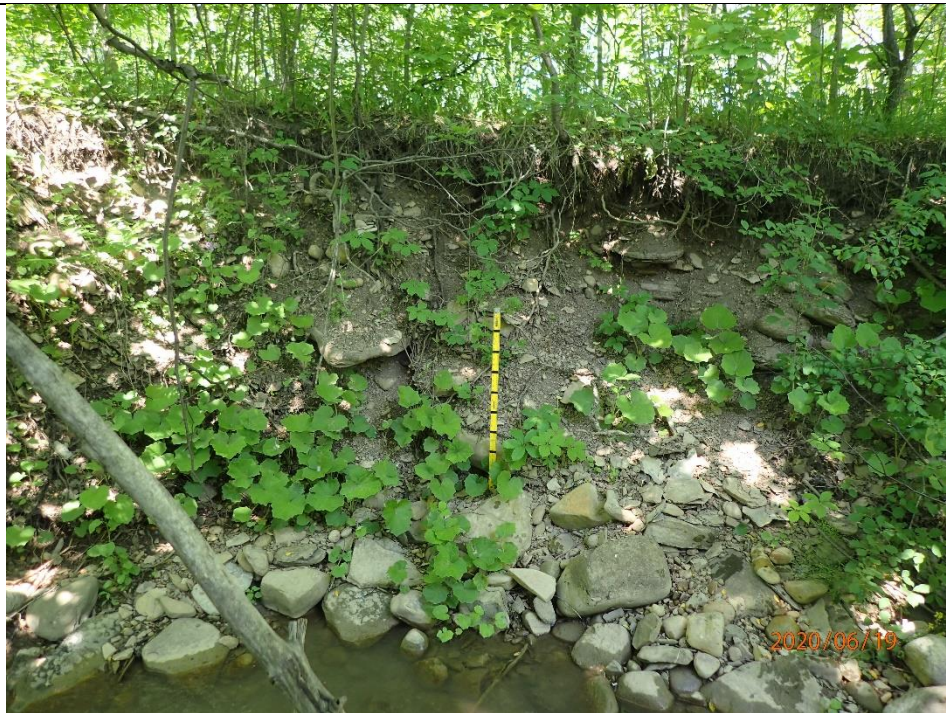
**Photo 14**  
Reach WC9 DS – Town of the Blue Mountains, Ontario

Valley wall contact was common through the upstream sections of the reach. Bank materials consisted of silt, sand, gravel, and cobble.

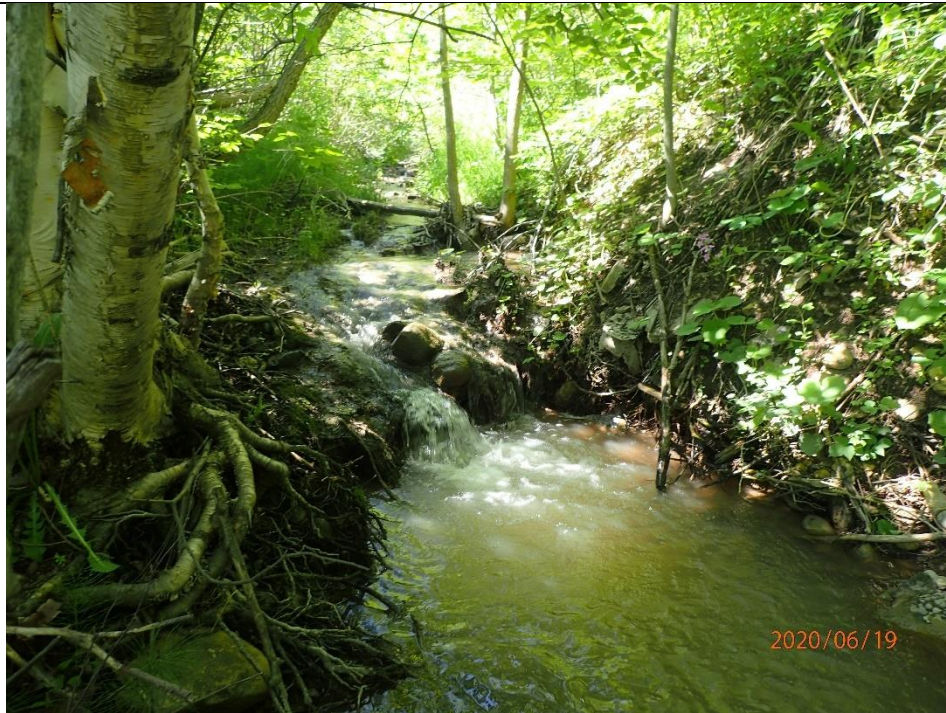
**Photo 15**  
Reach WC9 DS – Town of the Blue Mountains, Ontario

A transitional zone is pictured here, with substantial variation in gradient commonly observed throughout the upstream portion of the reach.

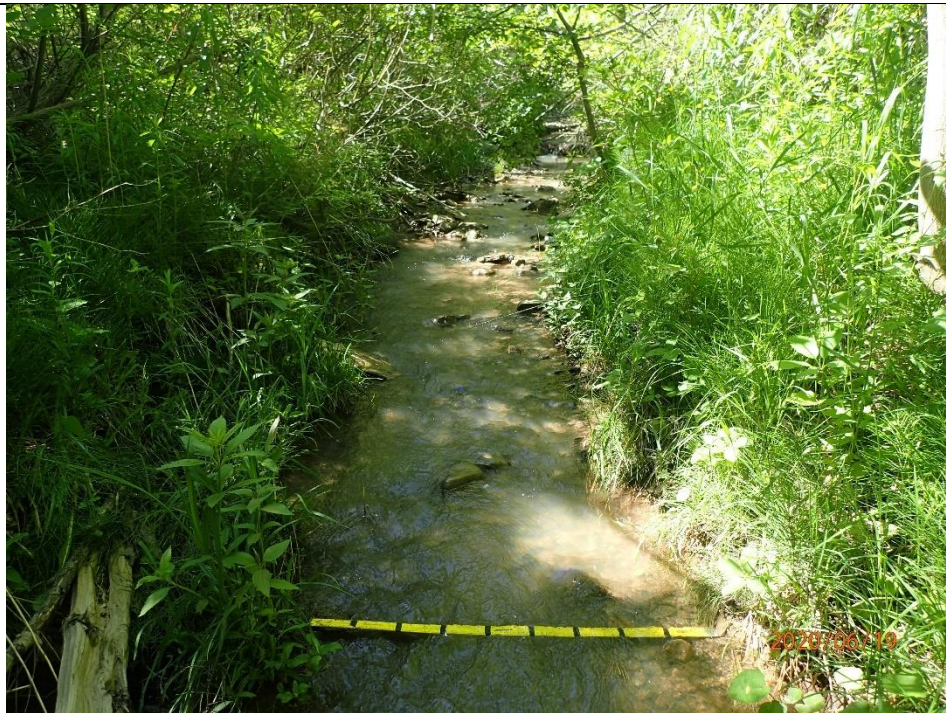
**Photo 16**  
Reach WC9 DS – Town of the Blue Mountains, Ontario

Banks were densely vegetated with a mix of trees, shrubs, and herbaceous species.

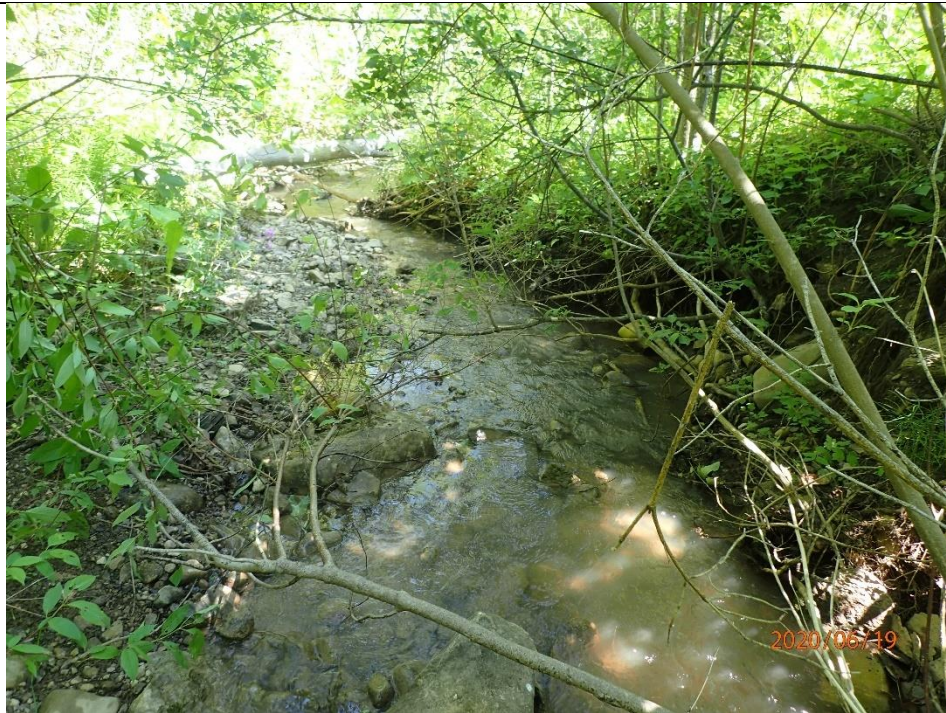
**Photo 17**  
Reach WC9 DS – Town of the Blue Mountains, Ontario

Looking downstream at the approximate location of an additional proposed outfall. Valley wall contact was observed at the right bank.

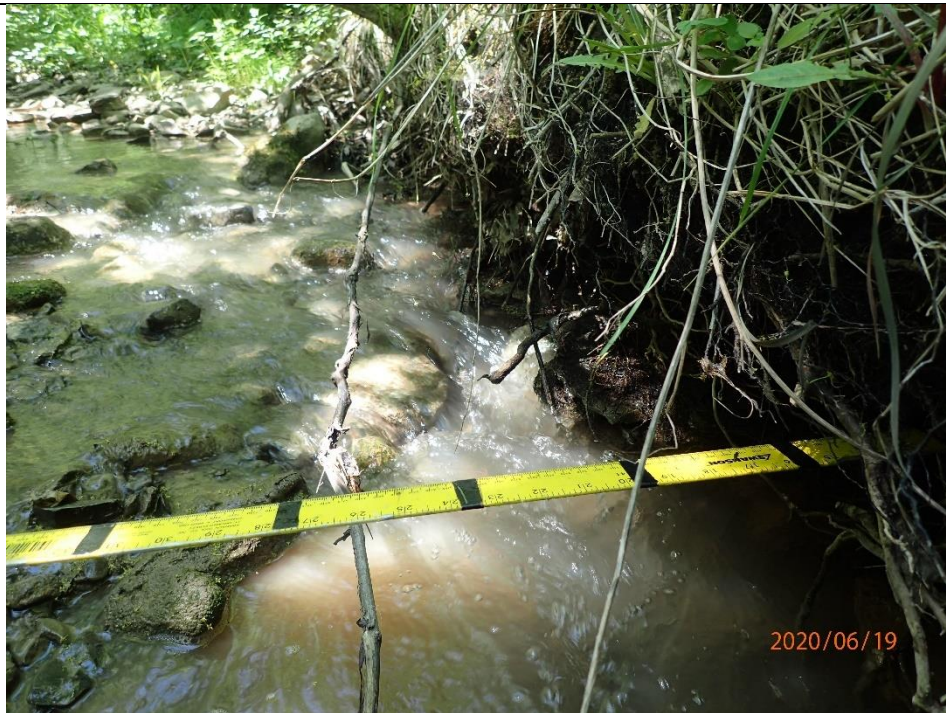
**Photo 18**  
Reach WC9 DS – Town of the Blue Mountains, Ontario

Undercutting was the dominant type of bank failure with undercuts measured up to 0.47 m. Young and old exposed tree roots were common.

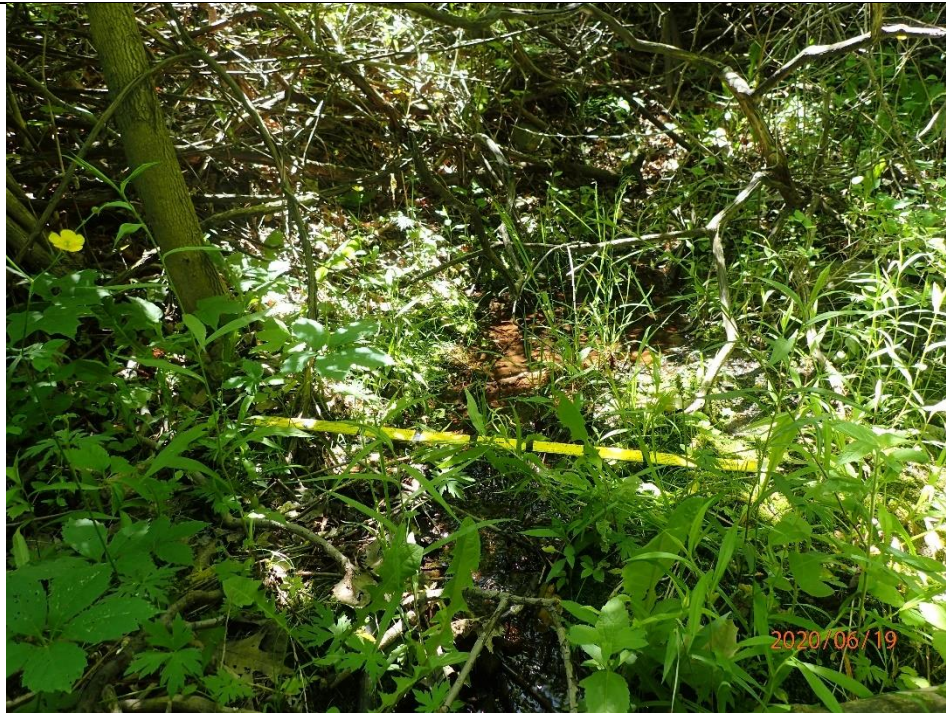
**Photo 19**  
Reach WC9 DS – Town of the Blue Mountains, Ontario

Iron staining along the channel bed and banks indicated there were groundwater contributions through the system.

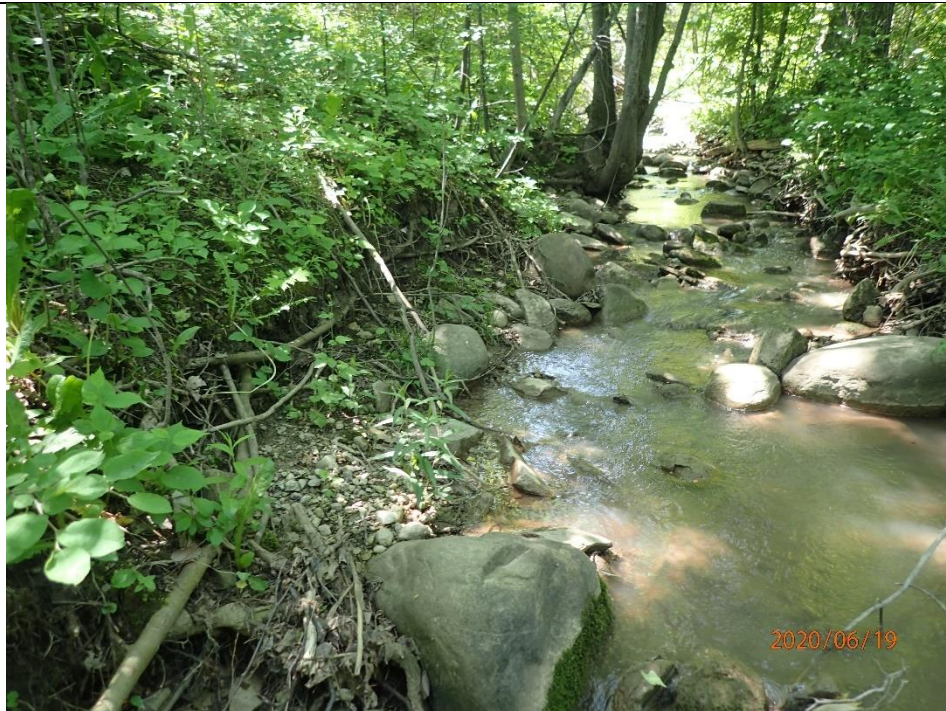
**Photo 20**  
Reach WC9 DS – Town of the Blue Mountains, Ontario

The reach was a defined, single-thread channel, with developed riffle pool sequencing. Forested canopy coverage provided > 80% shading throughout, enhancing riparian habitat conditions.

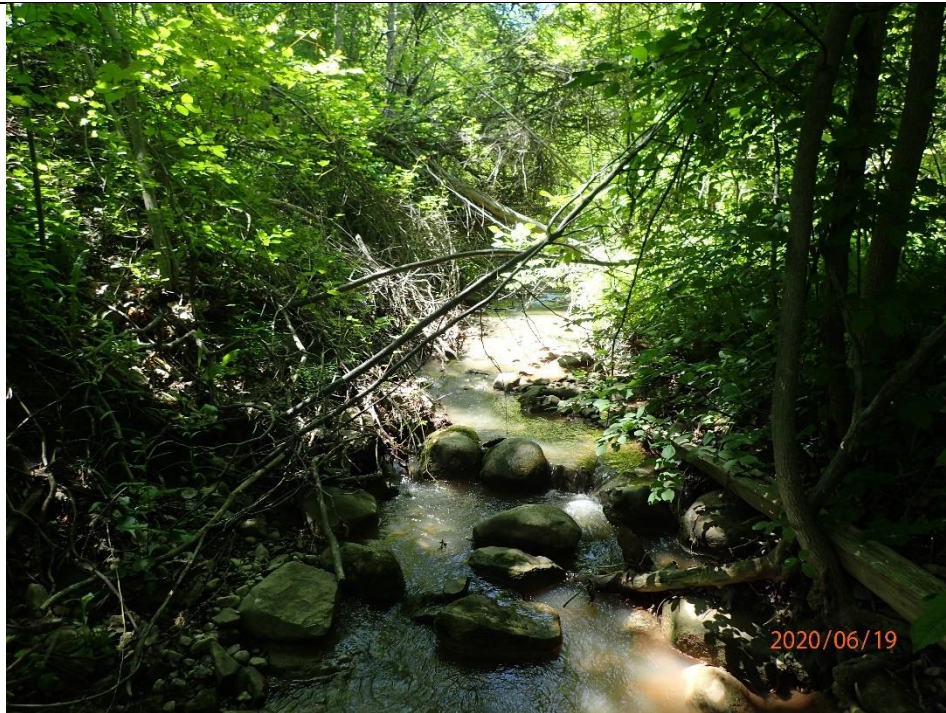
**Photo 21**  
Reach WC9 US – Town of the Blue Mountains, Ontario

Photograph taken looking upstream from the downstream extent of Reach WC9-US. A preliminary reach break was established based on field observations.

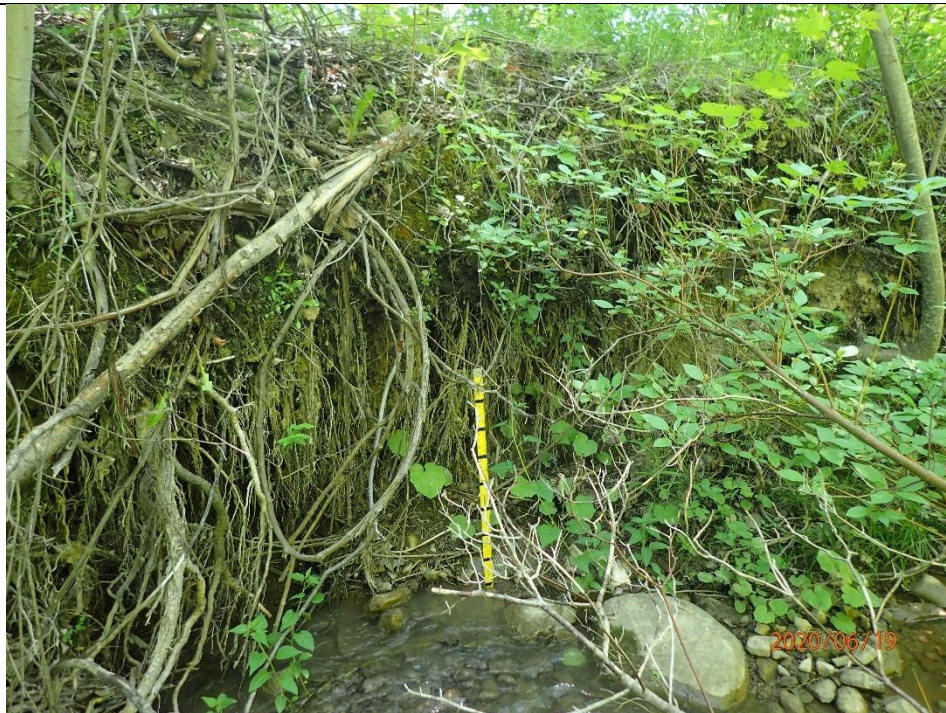
**Photo 22**  
Reach WC9 US – Town of the Blue Mountains, Ontario

The valley was partially confined at the downstream extent of the reach and was evident by frequent valley wall contact.

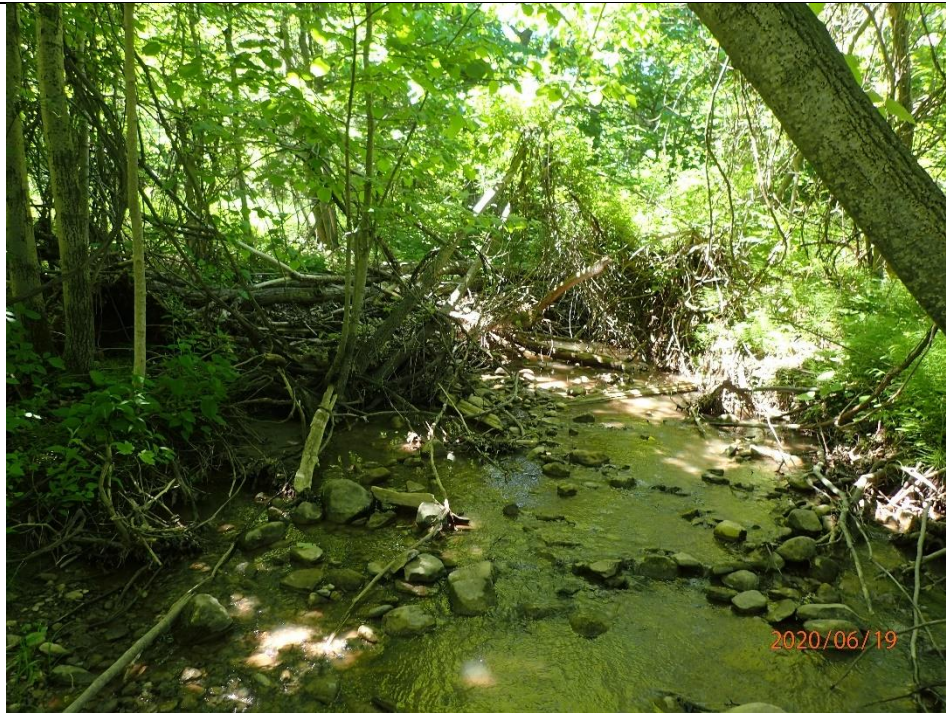
**Photo 23**  
Reach WC9 US – Town of the Blue Mountains, Ontario

Basal scour observed on both sides of the channel through riffles was indicative of widening processes.

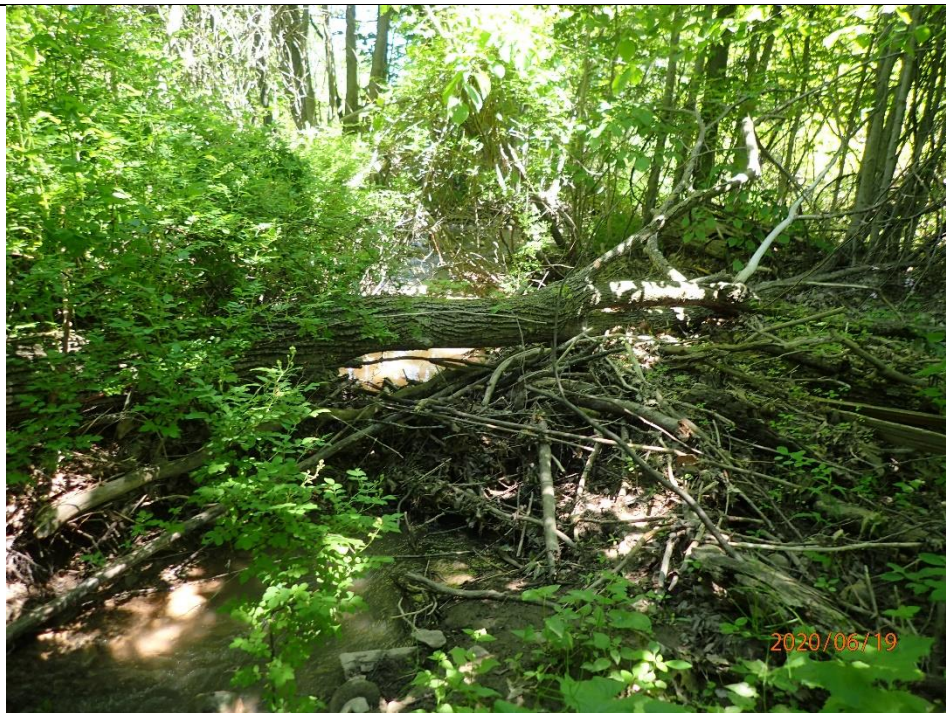
**Photo 24**  
Reach WC9 US – Town of the Blue Mountains, Ontario

There was a moderate density of woody debris present in the channel and cut bank. In some cases, woody debris was observed as fallen trees (pictured here). There were approximately 2 woody debris jams per 50 m of reach.

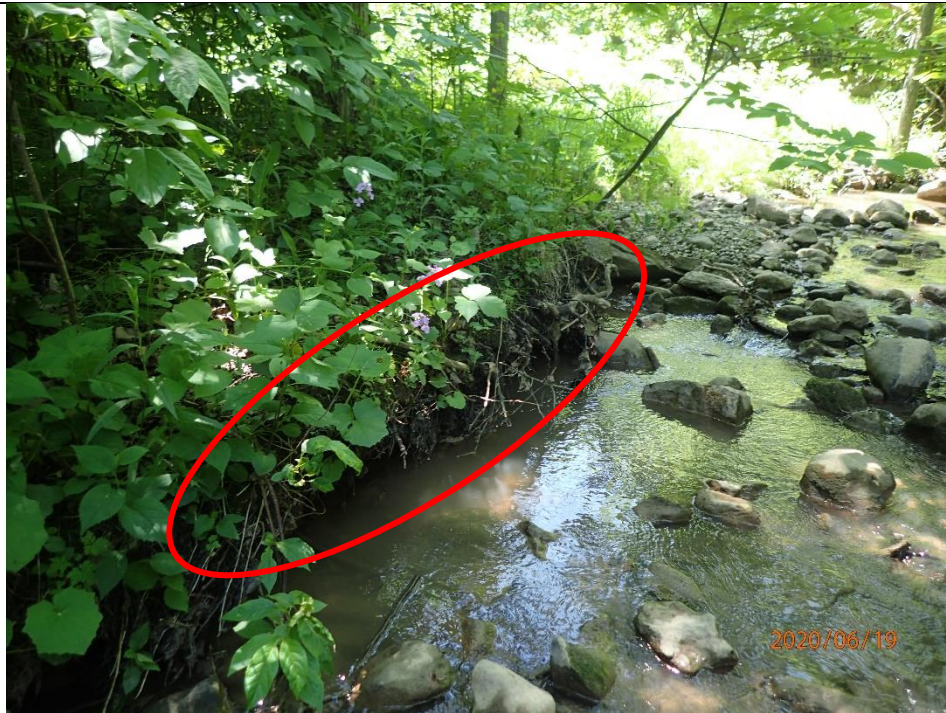
**Photo 25**  
Reach WC9 US – Town of the Blue Mountains, Ontario

Bank erosion was present through 30 to 60% of the reach and was observed through scouring of the channel banks and undercutting (circled).

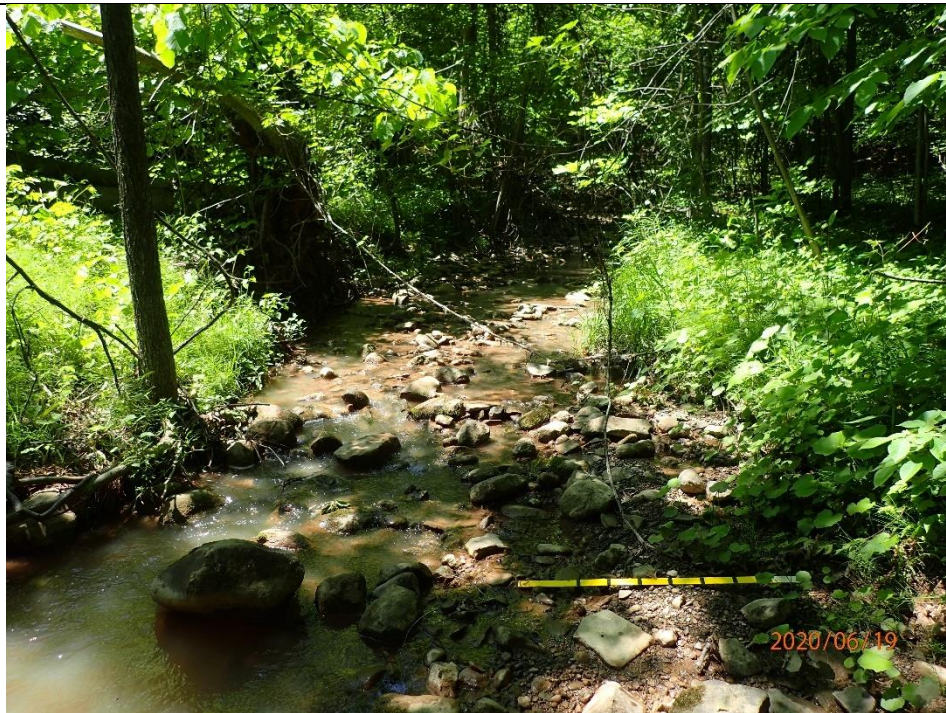
**Photo 26**  
Reach WC9 US – Town of the Blue Mountains, Ontario

Looking upstream at the approximate location of a proposed watercourse crossing, where an all-terrain vehicle trail currently exists.

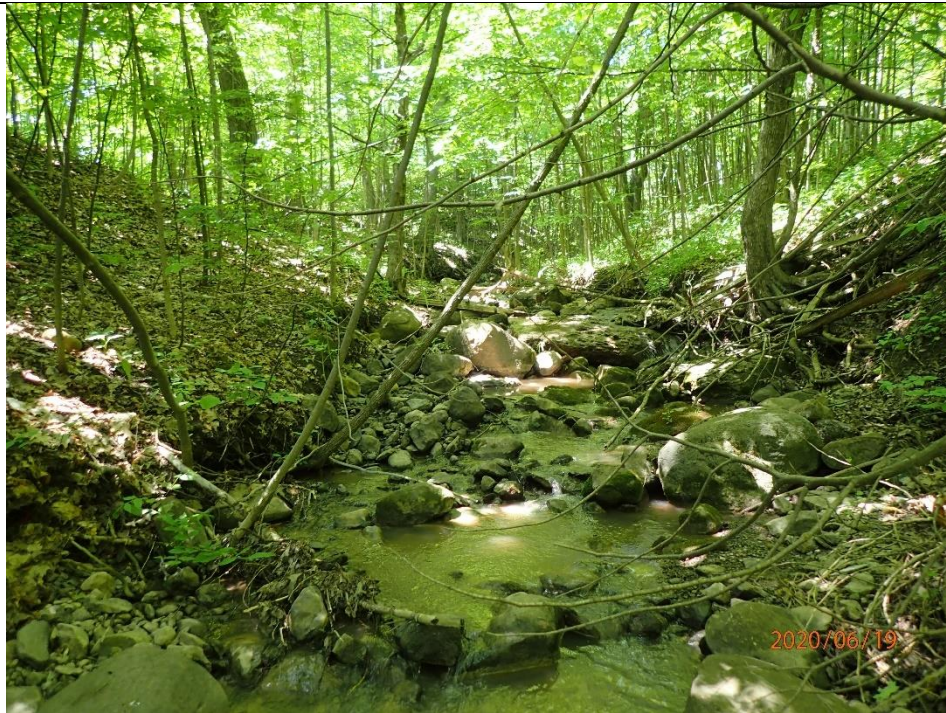
**Photo 27**  
Reach WC9 US – Town of the Blue Mountains, Ontario

Moving upstream, the valley transitioned to confined and outer bank heights increased to greater than 1 to 2 m above the stream bank, contributing to bank instability.

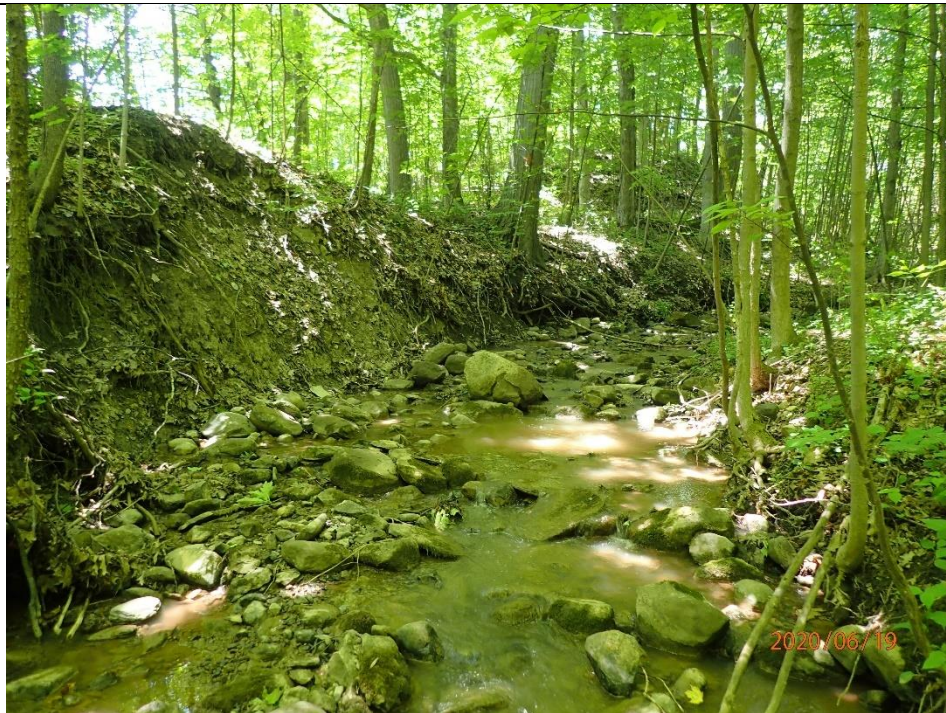
**Photo 28**  
Reach WC9 US – Town of the Blue Mountains, Ontario

Bank failure was present along outside meander bends. Undercuts up to 0.9 m were observed and exacerbated by leaning tree root systems.

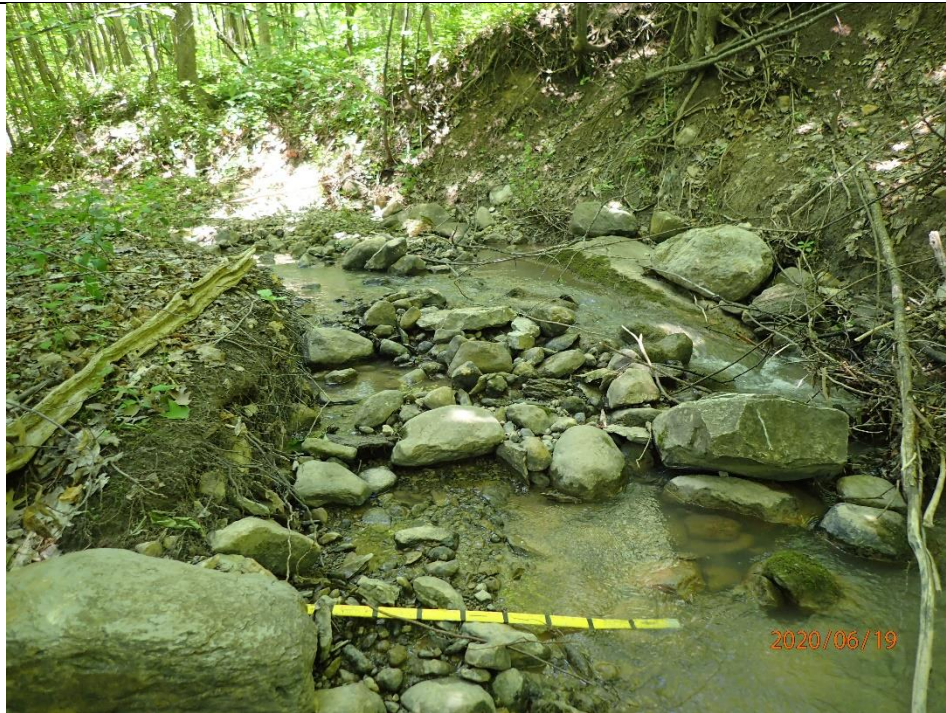
**Photo 29**  
Reach WC9 US – Town of the Blue Mountains, Ontario

Bar forms were poorly formed or reworked, and the thalweg was out of phase with meander form indicating planimetric form adjustment processes.

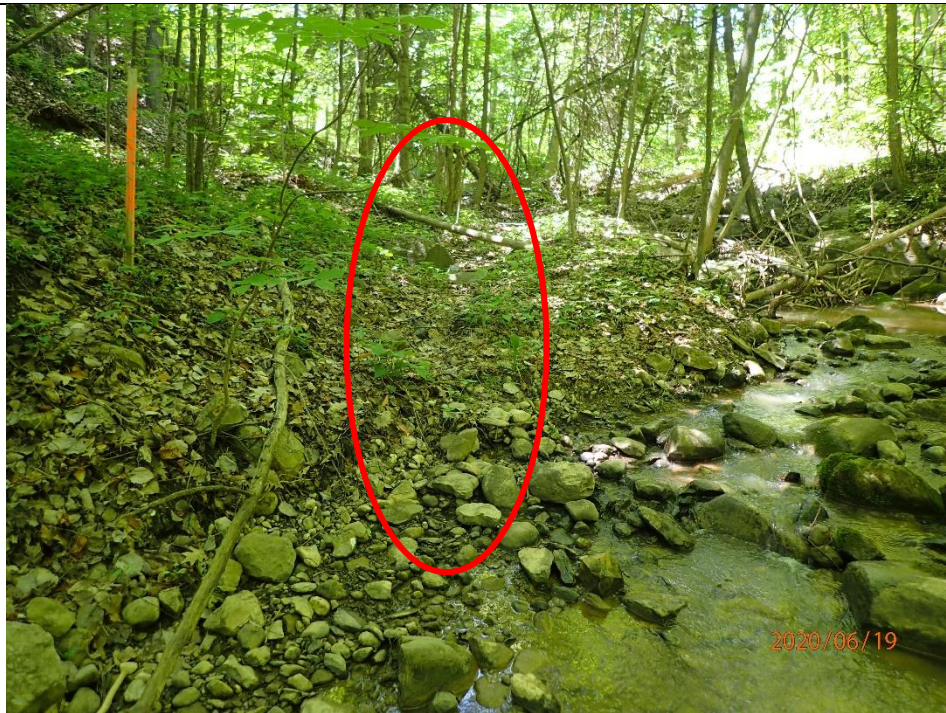
**Photo 30**  
Reach WC9 US – Town of the Blue Mountains, Ontario

Formation of a chute (circled) was observed providing further evidence of planimetric form adjustment.

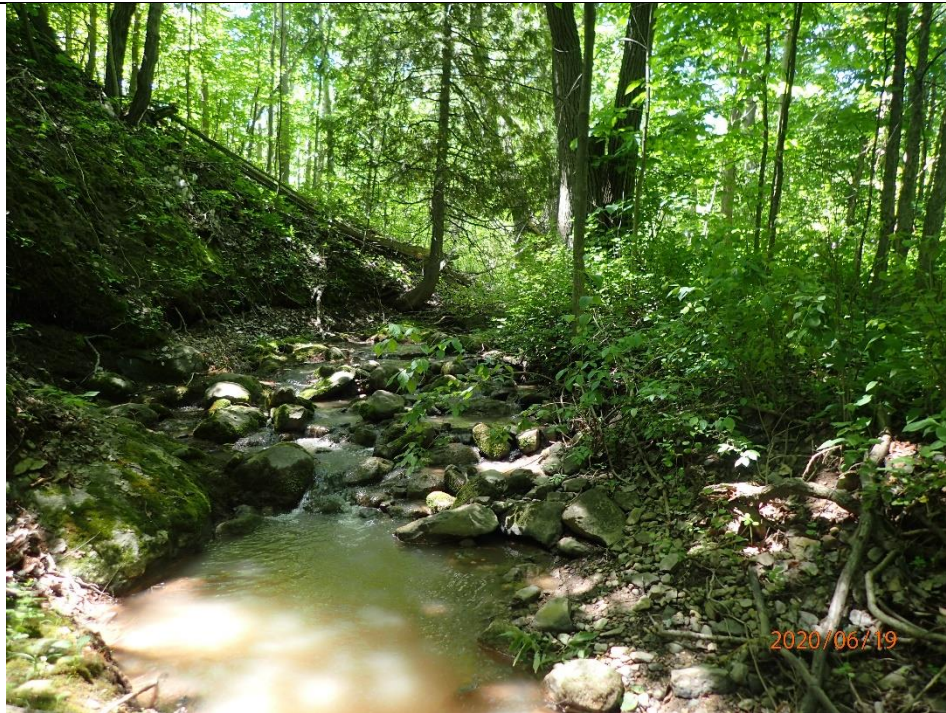
**Photo 31**  
Reach WC9 US – Town of the Blue Mountains, Ontario

Throughout the reach there were multiple points of valley wall contact. In this area, the base of the valley wall showed evidence of undercutting, and bank failure/fallen trees showed evidence of widening.
