# Geomorphological Assessment and Stabilization Recommendations

## Watercourse 9 – Craigeith Proposed Residential Development

Report Title: Fluvial Geomorphology Assessment and Stabilization  
Recommendations  
Watercourse 9 - Craigleith Proposed Residential  
Development

Project Number: PN20058  
Status: Final  
Version: 2.0  
First Submission Date: September 11, 2020

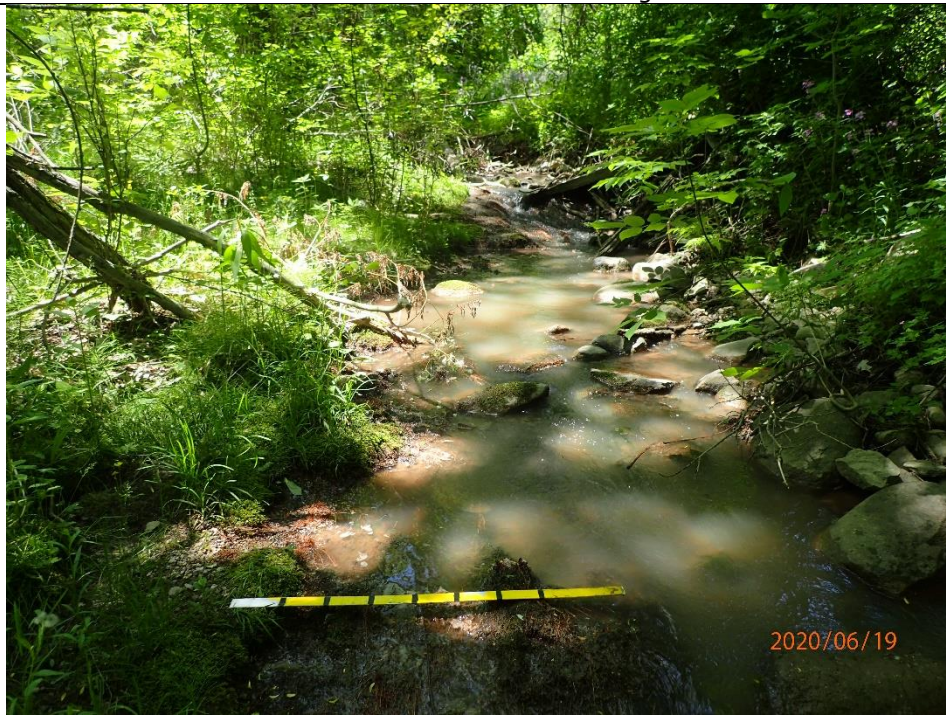
**Photo 32**  
Reach WC9 US – Town of the Blue Mountains, Ontario

Bank materials through the reach ranged from clay to sand. Bank failure was present frequently.

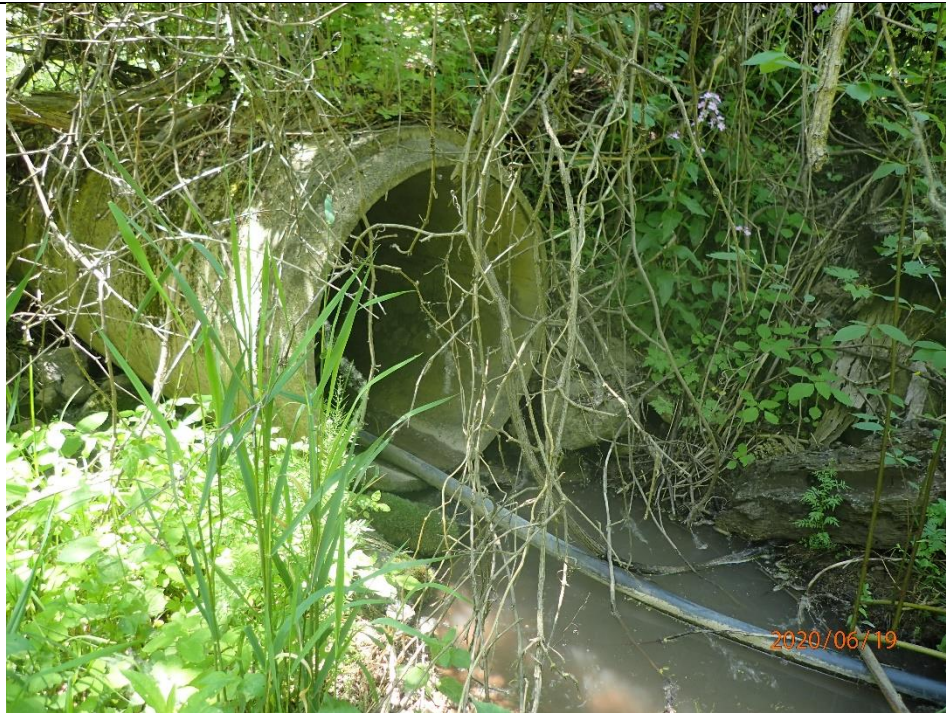
**Photo 33**  
Reach WC9 US – Town of the Blue Mountains, Ontario

An exposed storm sewer and length of previously buried pipe was located at the upstream extent of the reach. Surrounding bank erosion and undercutting was present. This is indicative of both degradation and widening at this location.

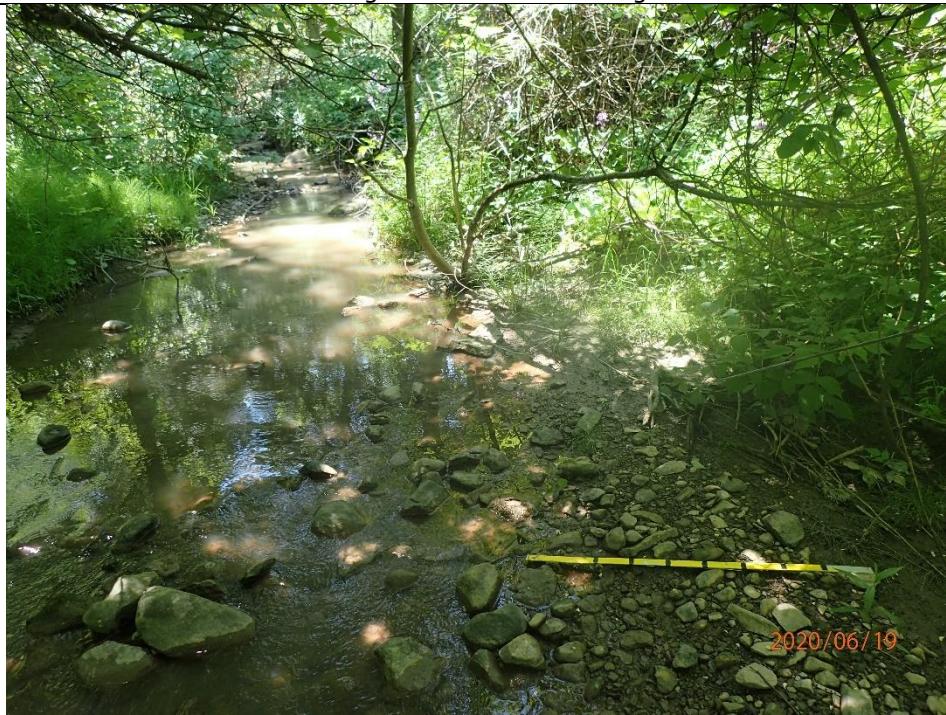
**Photo 34**  
Reach WC9 US – Town of the Blue Mountains, Ontario

Banks were densely vegetated with trees, shrubs, and herbaceous species providing canopy coverage of > 80% shading throughout most of the reach.

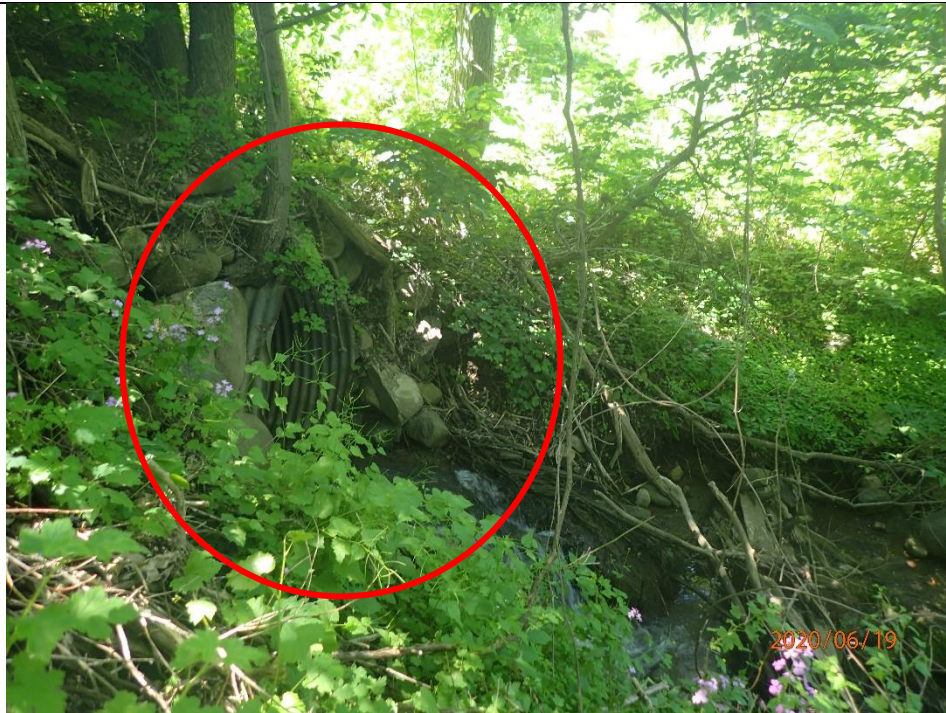
**Photo 35**  
Reach WC9 US – Town of the Blue Mountains, Ontario

An elevated outfall was observed at the downstream extent of an existing watercourse crossing. A scour pool was present immediately downstream, indicative of degradation.

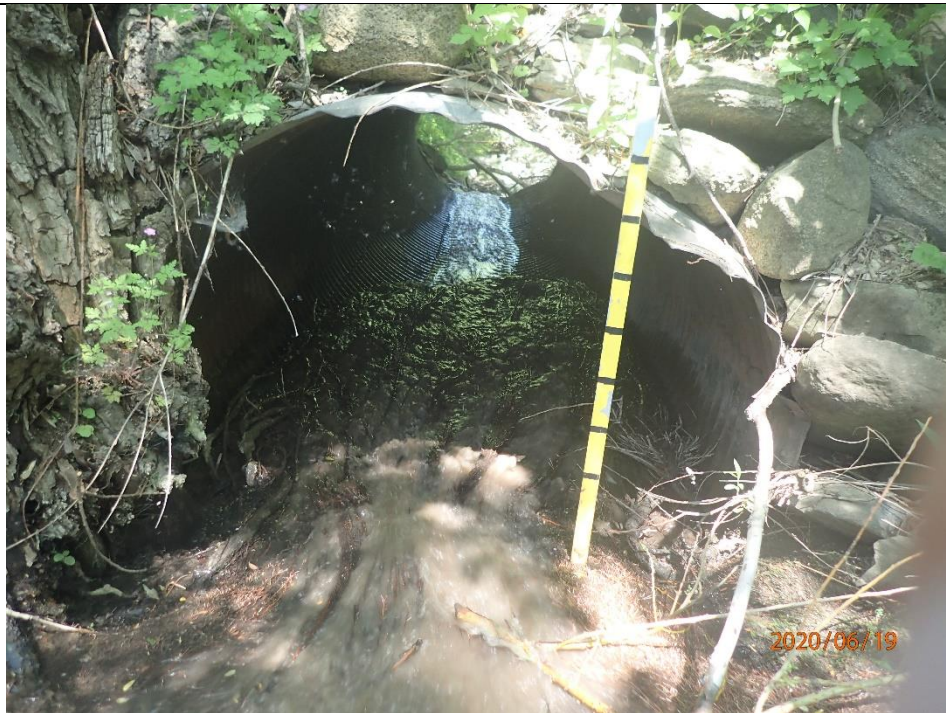
**Photo 36**  
Reach WC9 US – Town of the Blue Mountains, Ontario

Looking downstream at the existing crossing, where a future crossing is proposed. A rapid change in gradient was apparent.

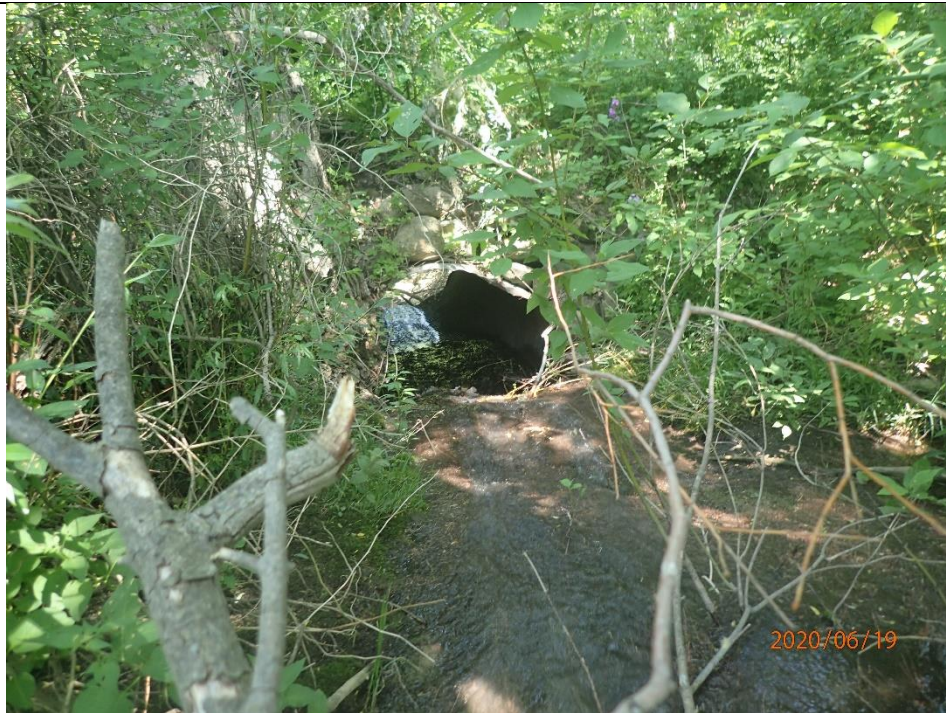
**Photo 37**  
Reach WC9 US – Town of the Blue Mountains, Ontario

Downstream view at the upstream extent of the reach. Evidence of widening and degradation were the key geomorphic indicators of channel stability through the reach.

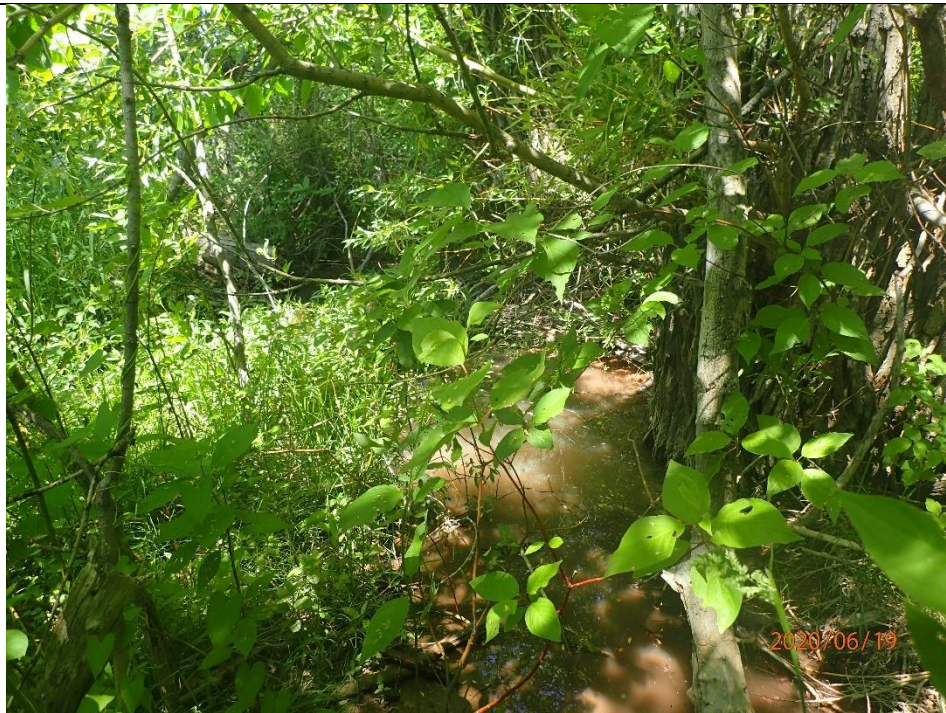
**Photo 38**  
Upstream Wetland – Town of the Blue Mountains, Ontario

Watercourse 9 was predominantly a wetland environment in the headwater zone where the channel originates.

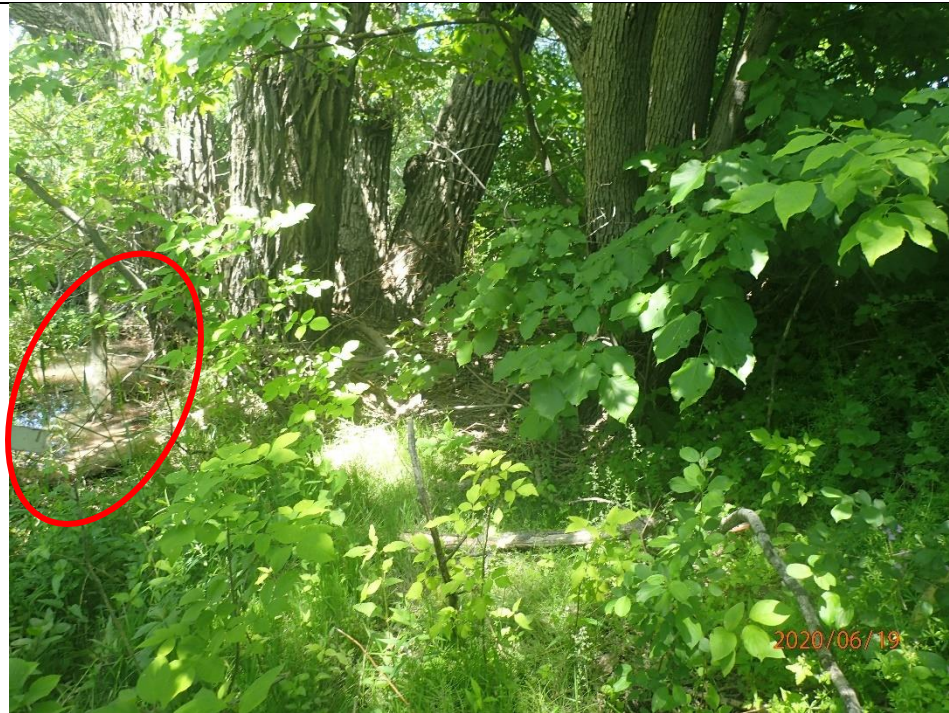
**Photo 39**  
Upstream Wetland – Town of the Blue Mountains, Ontario

Downstream view of the system at the upstream study limits. Pooling was present in the wetland dominated area (circled). No defined banks were observed.

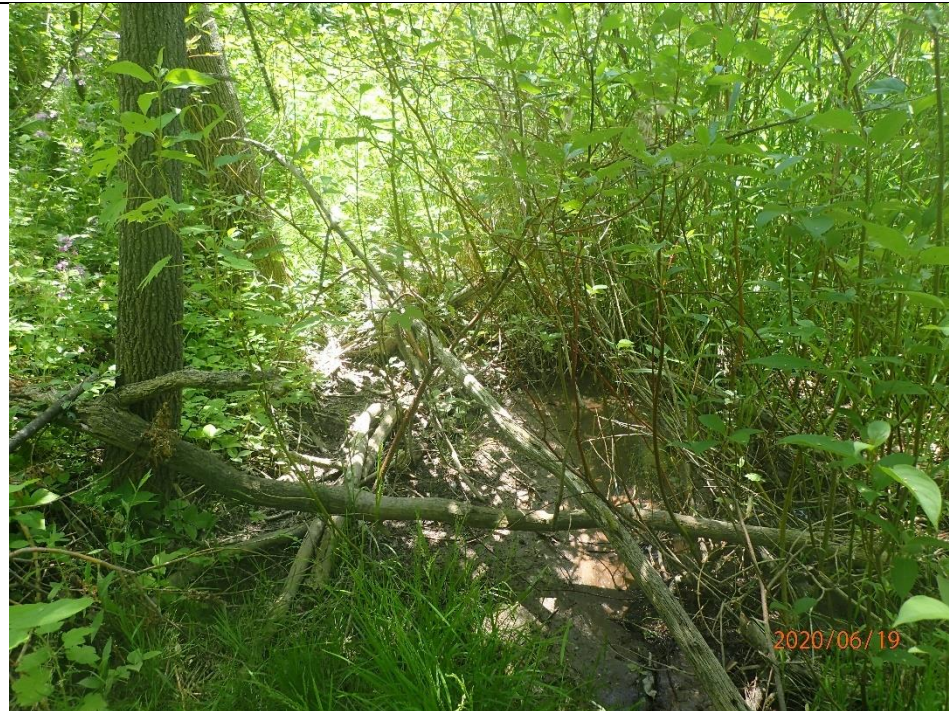
**Photo 40**  
Upstream Wetland – Town of the Blue Mountains, Ontario

Looking upstream at the upstream study limits. There was no defined channel or surface water observed.
