Hinds Brook Residential Development

EXISTING CONDITION NATURAL HAZARD ASSESSMENT

Homefield Management Ltd.

Issue	Date	Description
1	April 5, 2024	Final Report

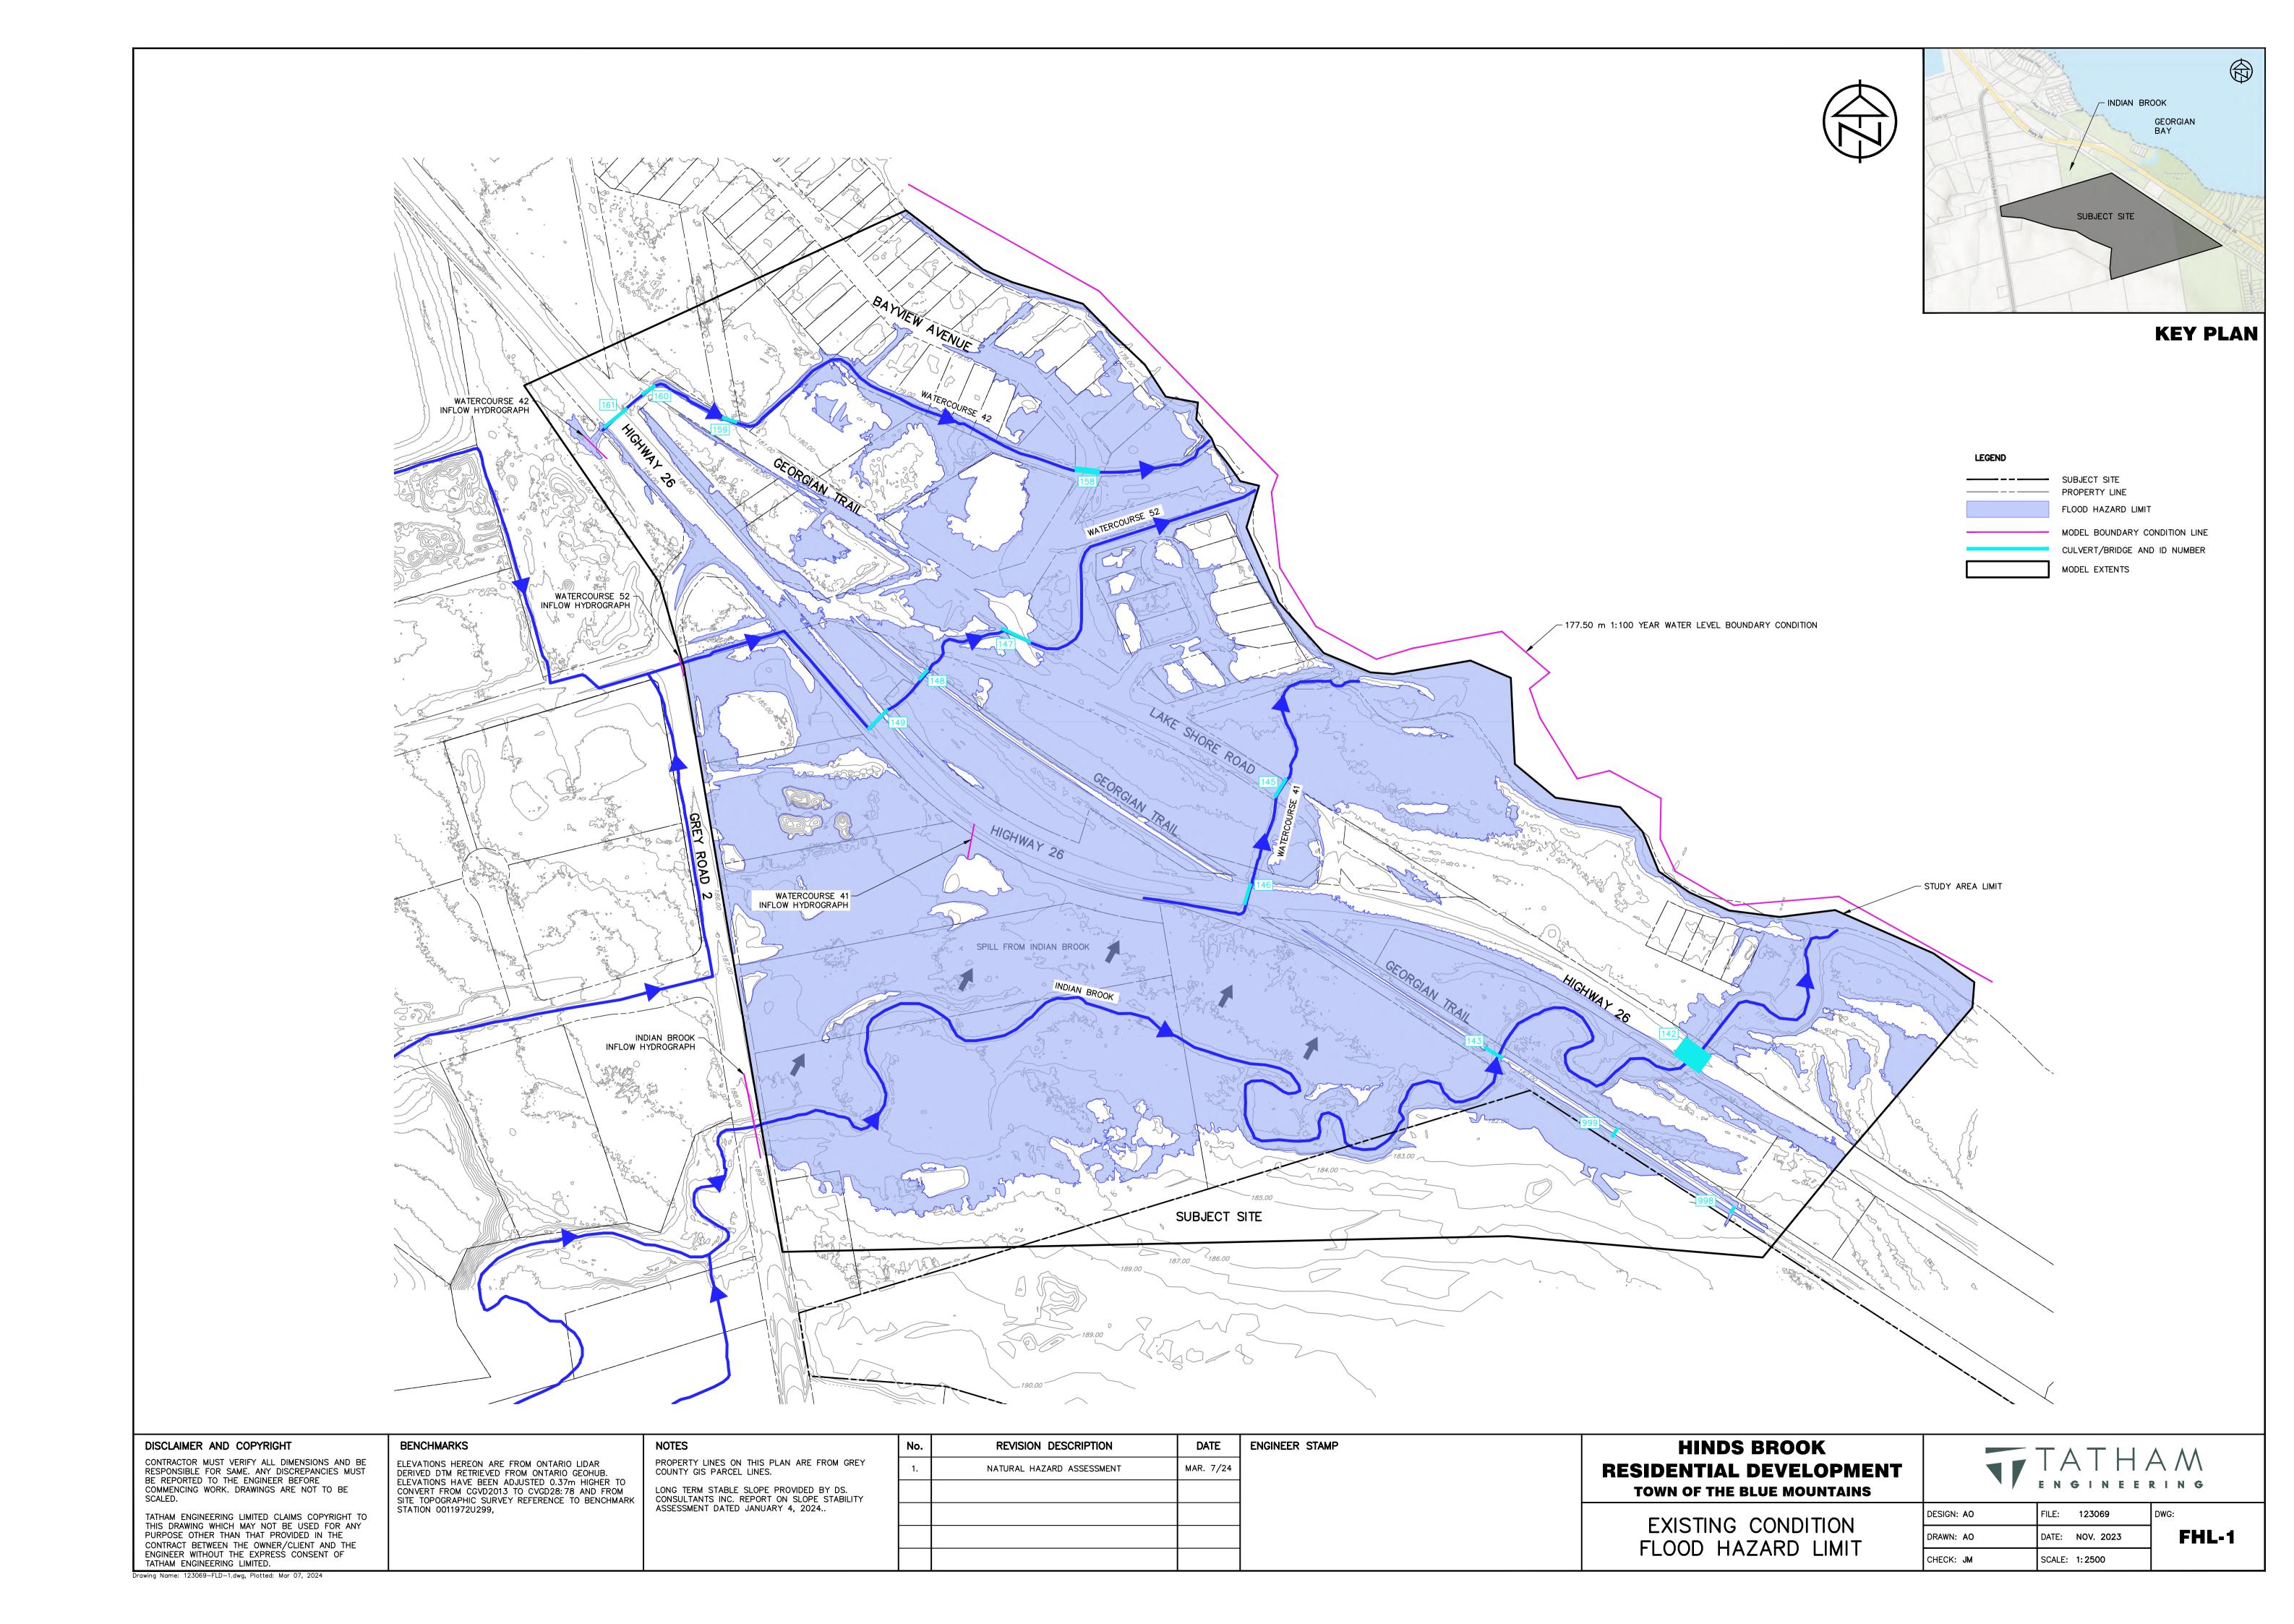
The flood hazard limit was established as the flood maximum inundation limit during the Timmins Regional Storm as shown on Drawing FHL-1 enclosed with this report as Figure 2 for reference.

As anticipated, adjacent to the site, there is a spill from Indian Brook in a northeast direction, towards Watercourses 41 and 52. This includes overtopping of Highway 26 north of the site between Grey Road 2 and the Georgian Trail and overtopping of the Georgian Trail between Highway 26 and the site. Overall, the flood hazard is confined by the south bank of Indian Brook across the site with the exception of a small area in the northeast corner of the site which is inundated due to backwater from the Georgian Trail Bridge crossing of Indian Brook (culvert/bridge ID 143). This flooded area on site is outside of the riparian and effective flow areas for the watercourse and could potentially be used for stormwater management (SWM) in accordance with GSCA's *Policies for the Administration of the Development, Interference with*

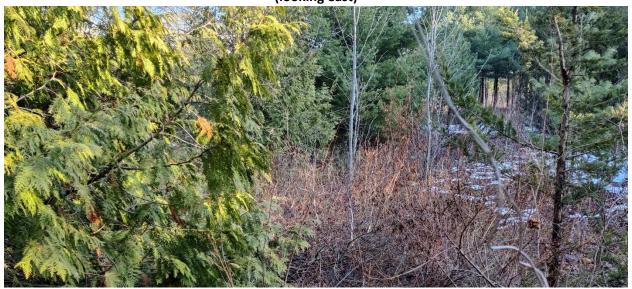
Photo P1: Top of slope conditions in west part of site near Section X1-X1 (looking east)

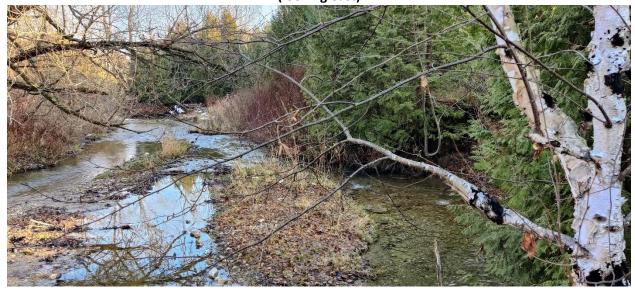
Photo P2: Creek and slope conditions in west part of site near Section X1-X1 (looking east)

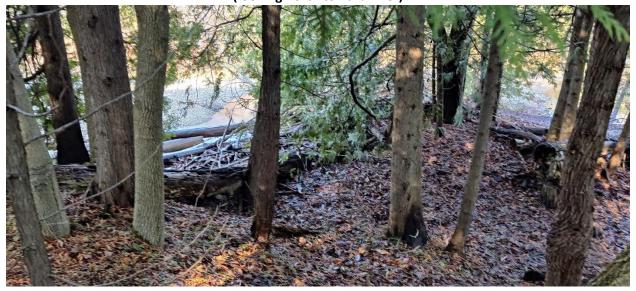
Photo P3: Top of slope conditions in area of Sections X3-X3 to X4-X4 (looking north toward river)

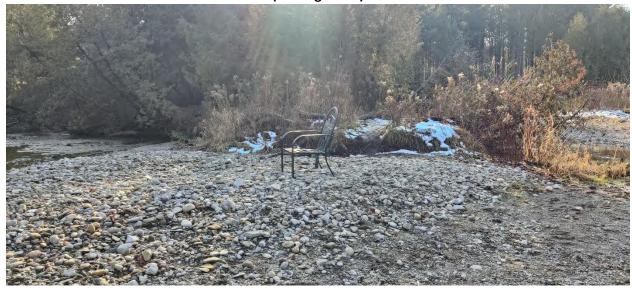
Photo P4: Slope and creek conditions in area of Sections X3-X3 to X4-X4 (looking south)

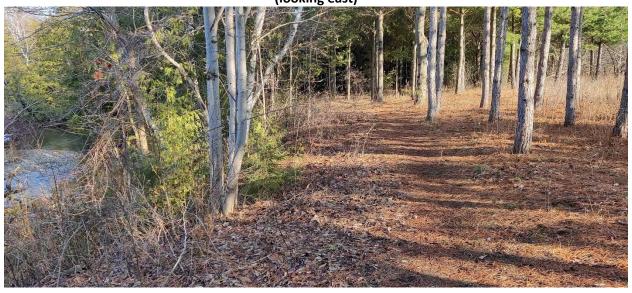
Photo P5: Top of slope conditions in area of Sections X4-X4 to X5-X5 (looking east)

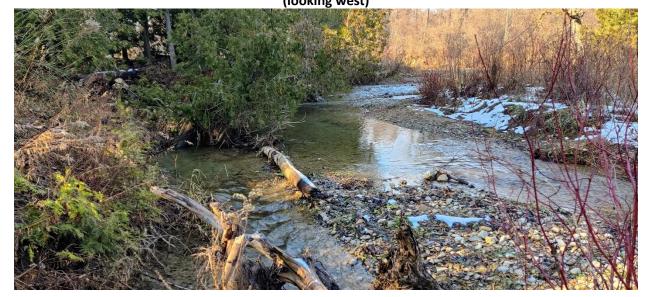
Photo P6: Creek and slope conditions in area of Sections X4-X4 to X5-X5 (looking west)

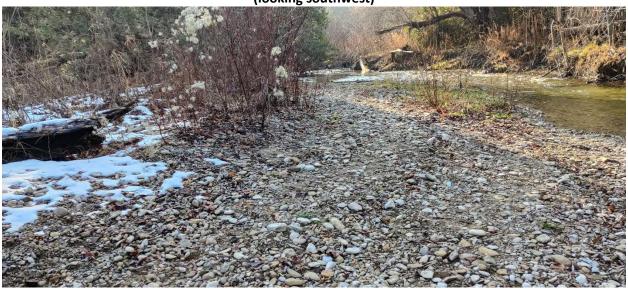
Photo P7: Creek and slope conditions in area to west of Section X10-X10 (looking southwest)

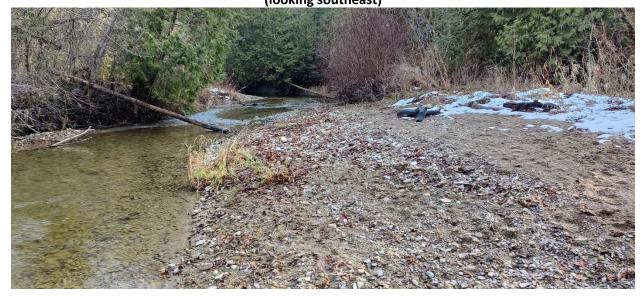
Photo P8: Creek and slope conditions in area to east of Section X10-X10 (looking southeast)

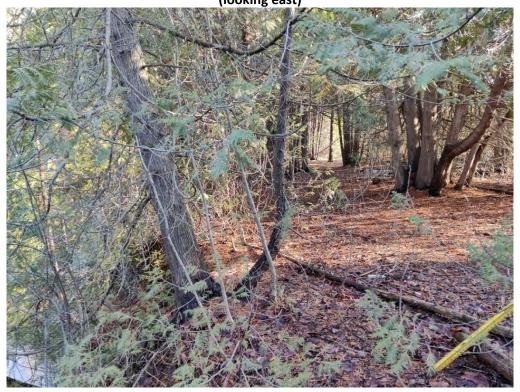
Photo P9: Top of slope conditions in east part of site near Section X13-X13 (looking east)

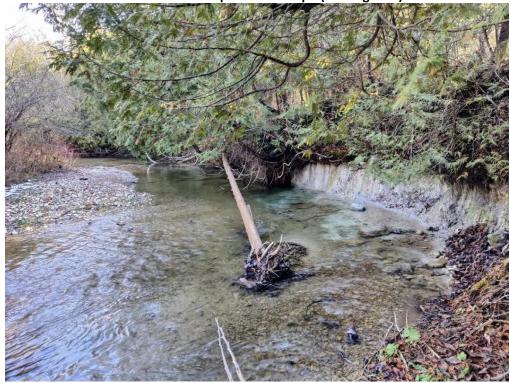
As indicated in Section 3.1 of this report, Indian Brook (the creek) at the site is typically 5 to 15 m wide. Erosions were observed at the creek bank at various locations.

Photo P10: Creek and slope conditions in east part of site near Section X13-X13, with Erosions at lower portion of slope (looking east)
