Staff Report

Report To: Committee of the Whole
Meeting Date: May 15, 2017
Report Number: CSPW.17.054
Subject: Black Bridge Rehabilitation – Steel Railing Design
Prepared by: Jim Mc Cannell, Manager of Roads and Drainage

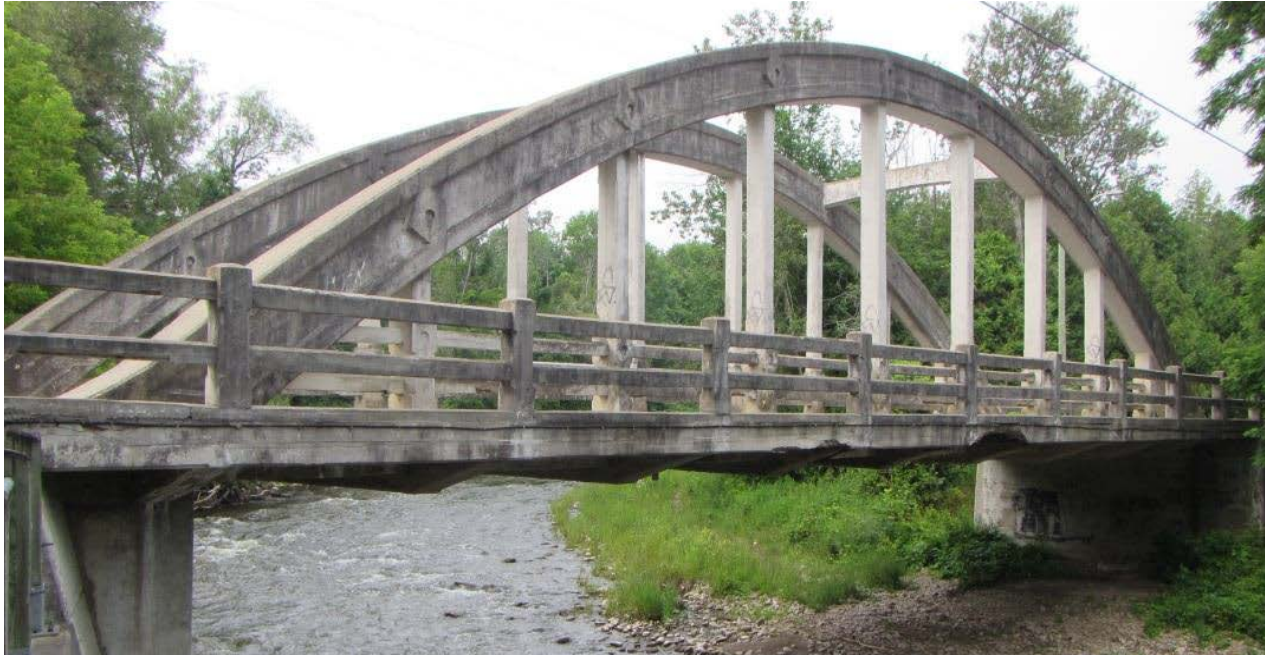
The bridge, constructed in 1923, is a single lane reinforced concrete bow string arch structure with an asphalt wearing surface placed over the concrete deck. The overall span length of the bridge is 25.3 m. The structure has railings between the roadway and the concrete sidewalk and a hand railing on the north side. Refer to Photo #1.

Photo #1: Black Bridge Structure

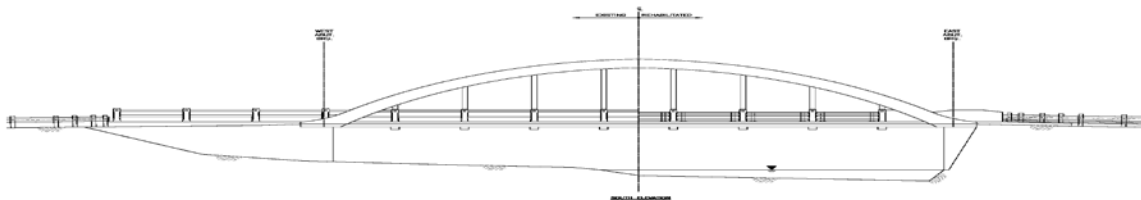
The proposed works will include two types of metal guide rails. Adjacent to the traveled lane will be crash rated guide rails that resemble the current concrete railings. These can be seen in the sketch below. These sections will have horizontal beams matching the concrete railings. Refer to sketch #1. The sketch shows both the original guiding and the proposed metal guide railing.

Sketch #1: Black Bridge with original and proposed metal guide railing.

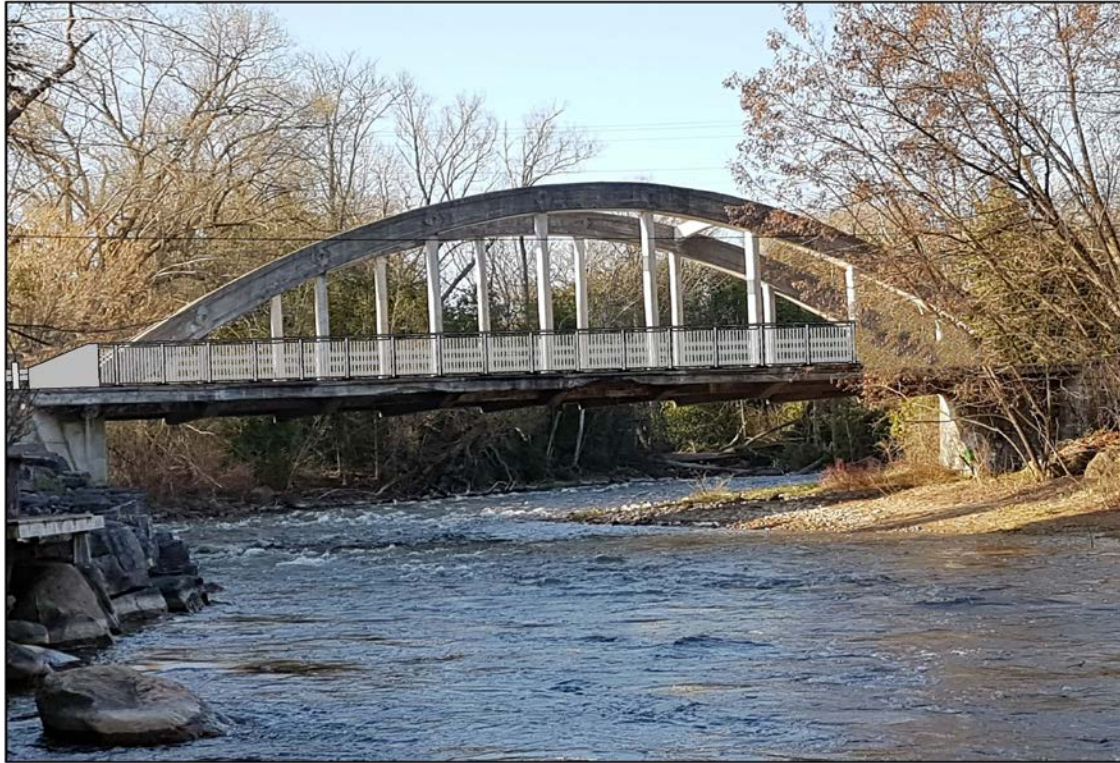
Adjacent to the walkway a second metal guide railing type will be installed. This guide rail section needs to be non-climbable and will have vertical metal sections. The look of this railing has been included in the picture below. Refer to Photo #2.

Photo #2: Black Bridge with vertical metal sections

All metal or steel guide railing on the bridge will be galvanized and then power coated in grey to match with the concrete finish.
