# Geomorphological Assessment and Stabilization Recommendations

## Watercourse 9 – Craigeith Proposed Residential Development

Report Title: Fluvial Geomorphology Assessment and Stabilization  
Recommendations  
Watercourse 9 - Craigleith Proposed Residential  
Development

Project Number: PN20058  
Status: Final  
Version: 2.0  
First Submission Date: September 11, 2020

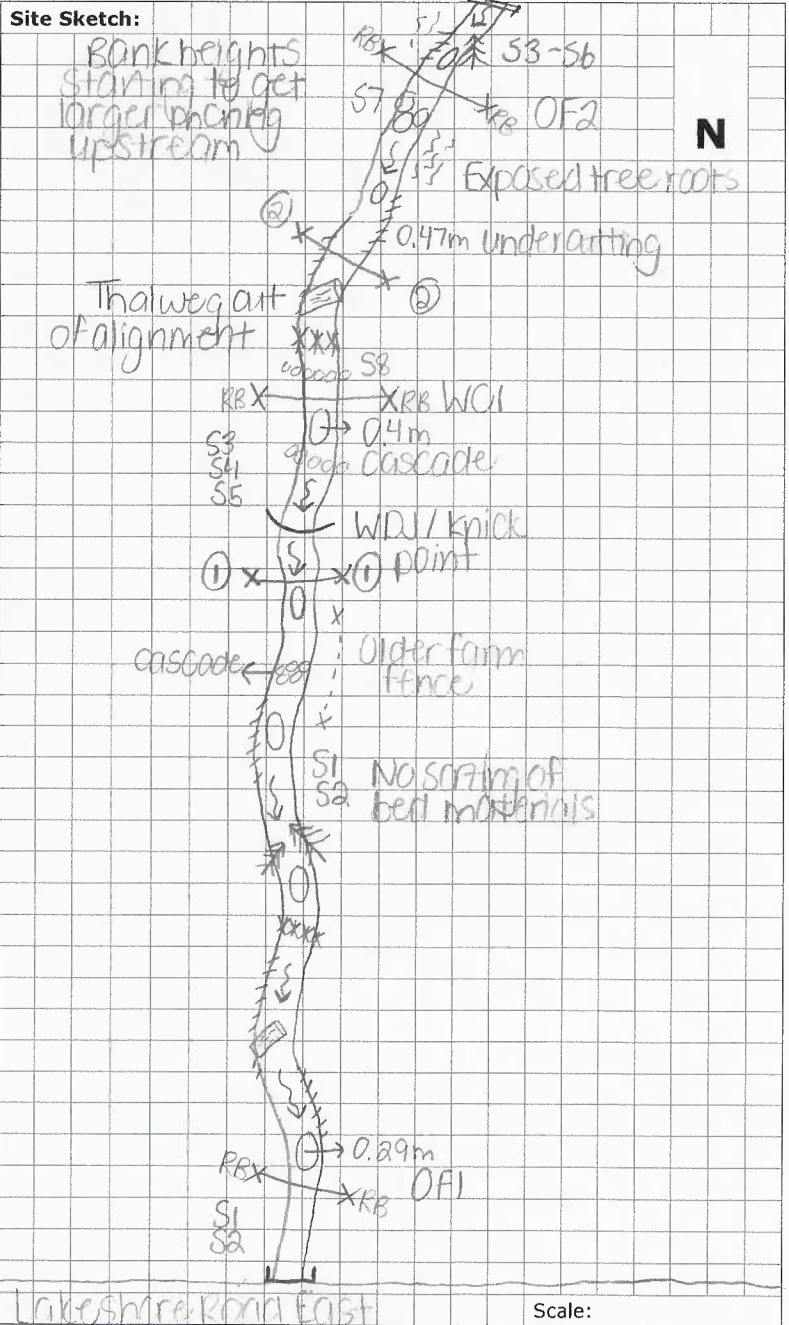
**Additional Notes:** Lots of WDJ, unconfined system flowing into confined system, dense vegetation throughout, monumented cross-sections established at crossing + outfall locations, velocity measurements collected at crossing + outfall locations.

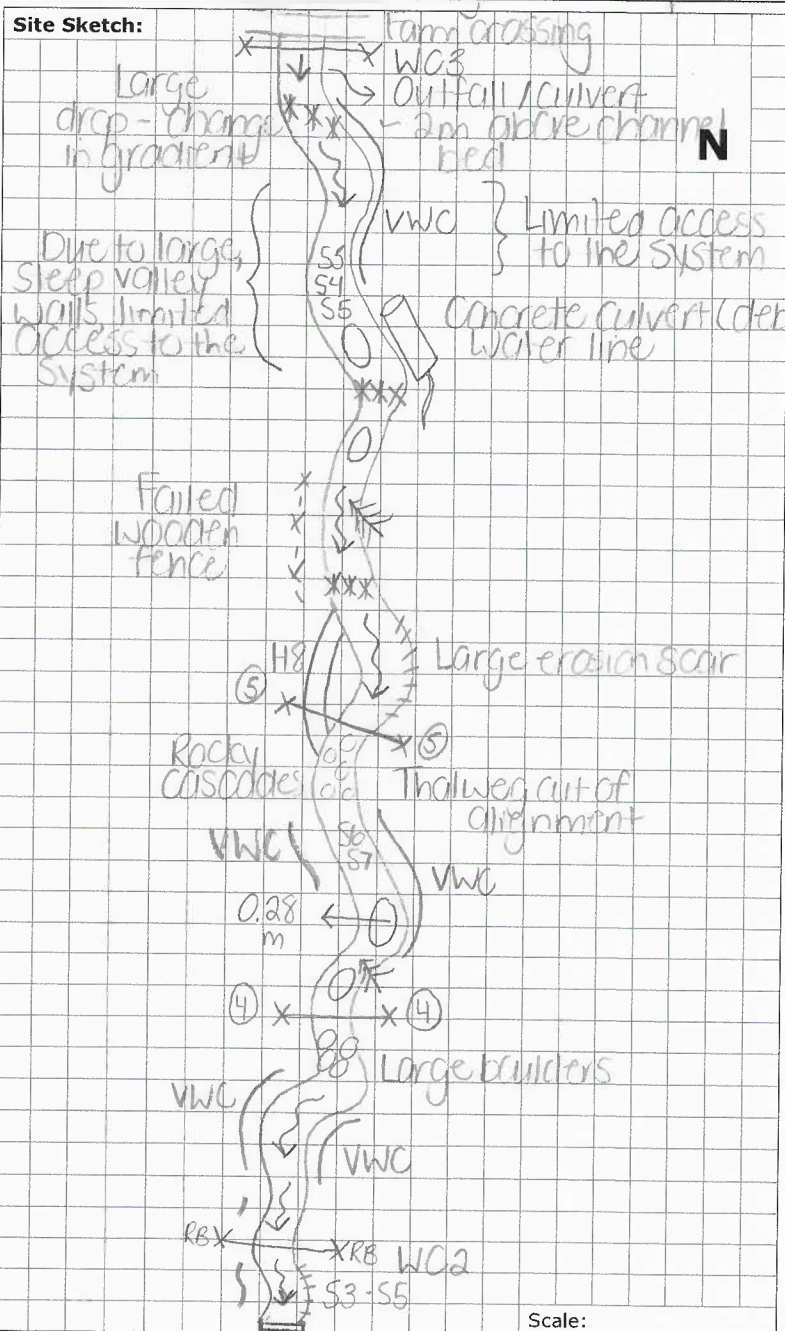
**Additional Notes:** Valley wall contact through the reach, limited access upstream due to steep valley walls, large drops/changes in gradient, fish passage obstructions, opportunities for improved connectivity
